Brynwood Golf & Country Club

568 Bedford Road
Town of North Castle
Westchester County
New York

VIII. APPENDIX

Phase IA Archaeological and Historic Resources Investigation
Brynwood Golf and Country Club
568 Bedford Road (NYS Route 22), Armonk, Town of North Castle
Westchester County, New York

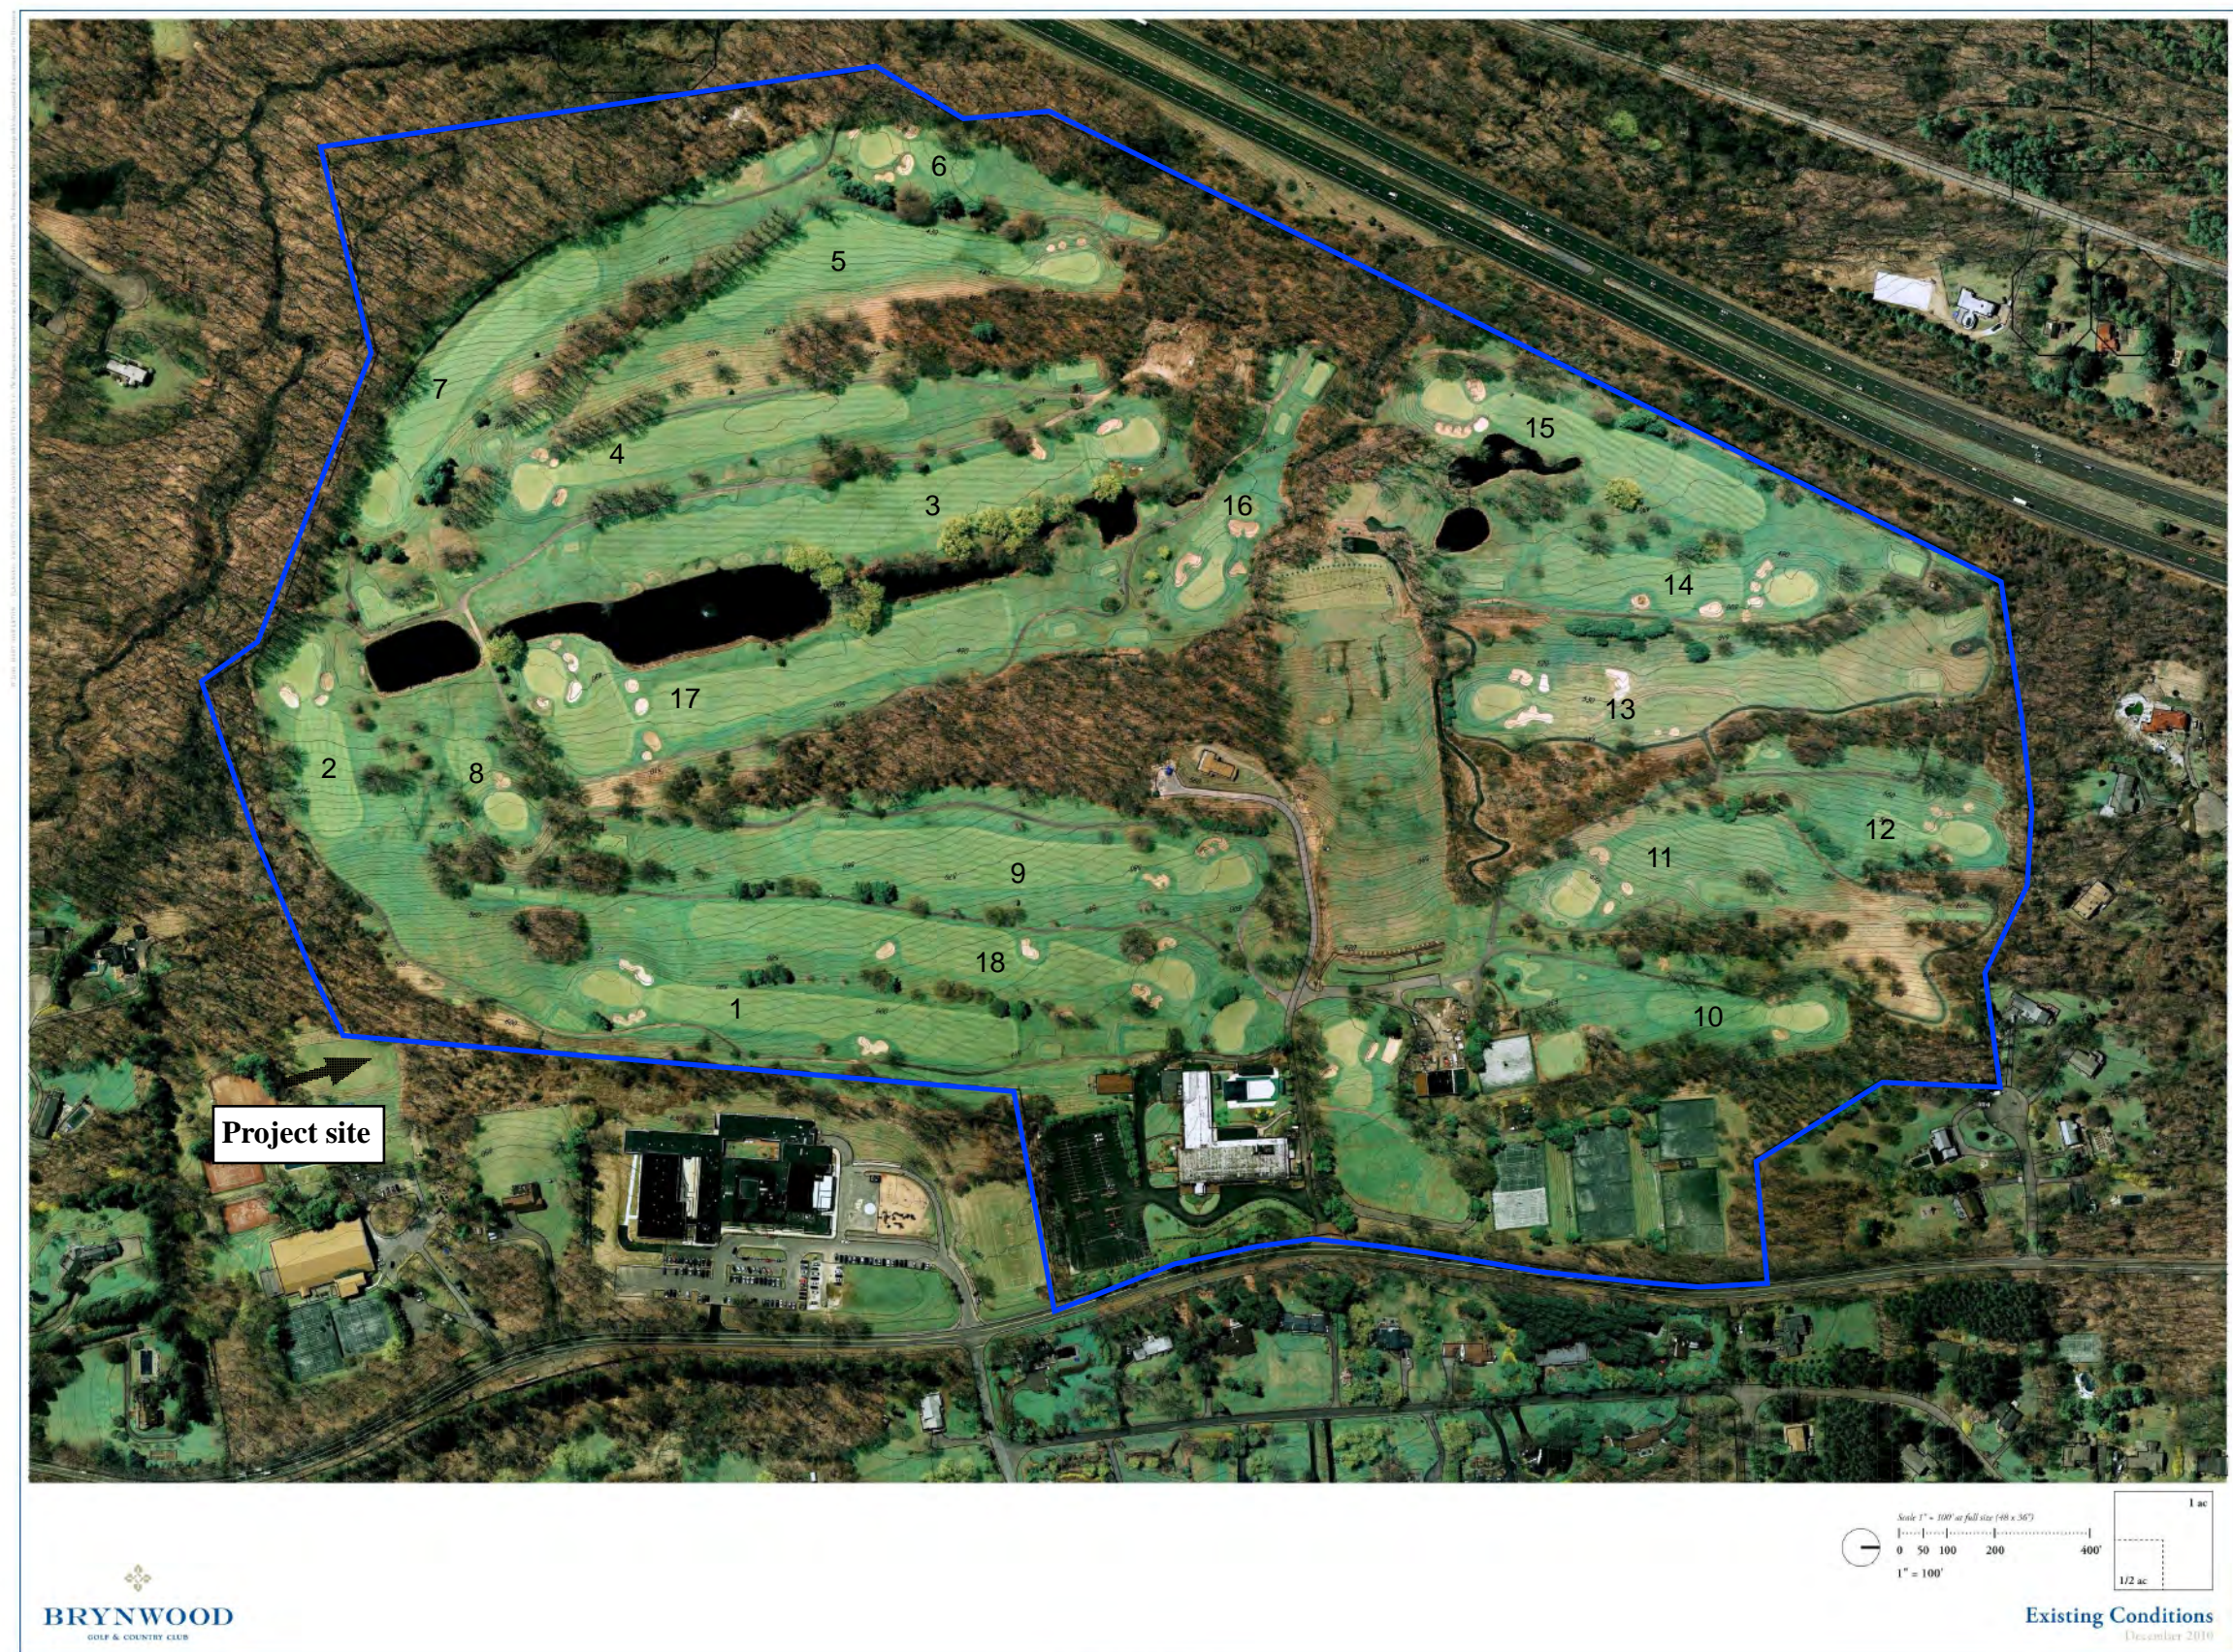
Figure 3: Existing conditions survey including numbered fairways (Hart Howerton 2010).

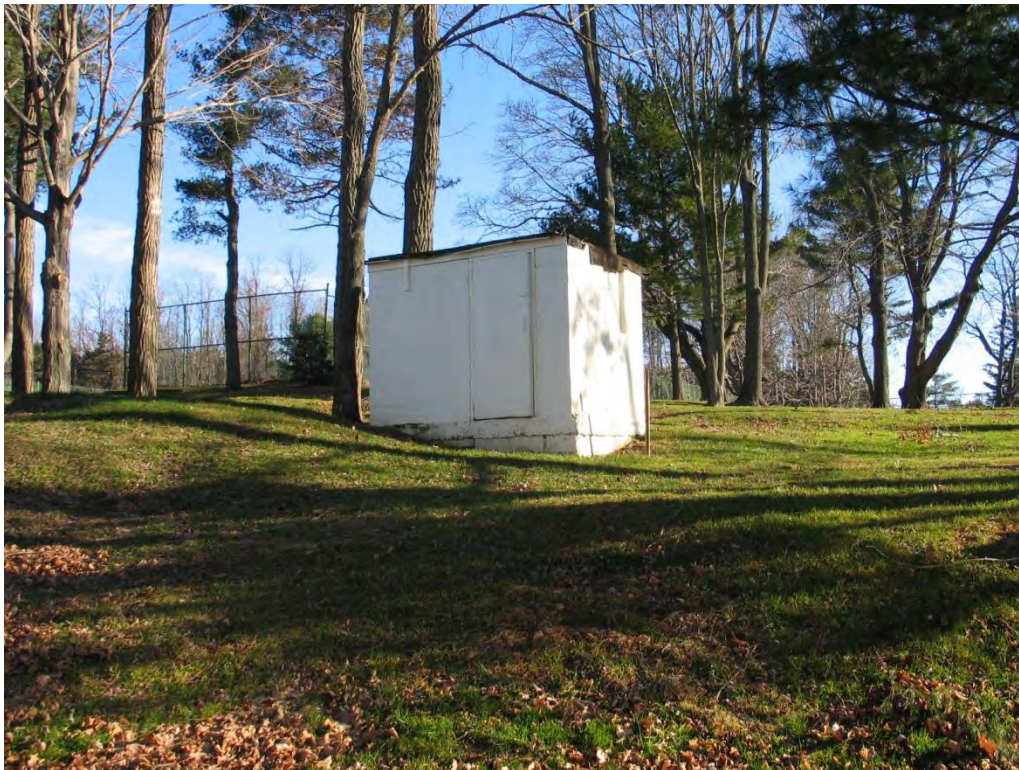
Photograph 10: Former pump house building east of the maintenance building. View looking northeast.

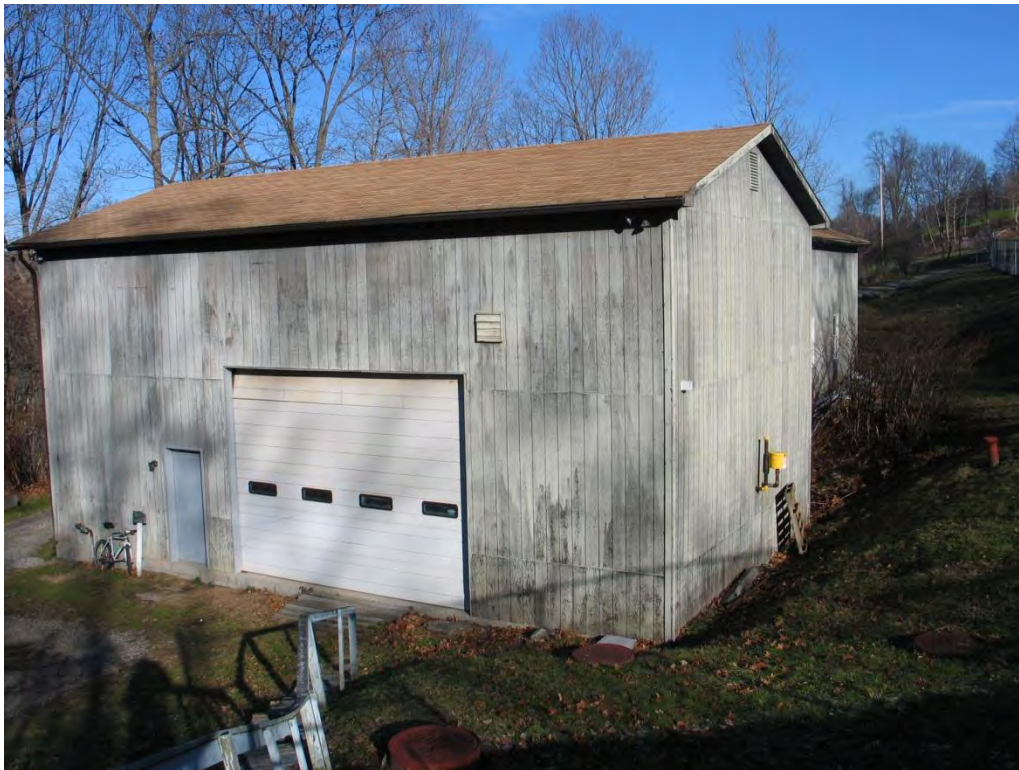
Photograph 14: Sewage plant, located on the interior of the property. View looking northwest.
