# North Castle Court and Police Facility Assessment

## A Survey of Conditions at 15 Bedford Road

Prepared for  
Town of North Castle, New York

Prepared by  
Paul A. Bishop, MPA, and Alina Santiago, MPA

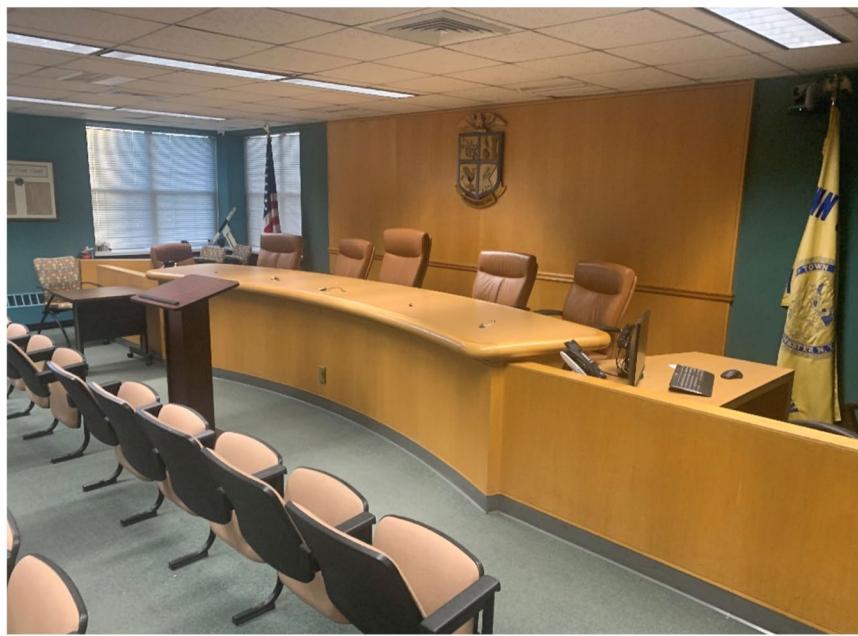
Figure 1- Front of Courtroom

- **There is no jury box.**
  - North Castle Town Court does conduct jury trials on occasion. There is no jury box in the current courtroom. A six-person jury sits in the second to last row of public seating during a jury trial with two alternatives sitting behind them in the last row.
  - NYS Section 34.0 states that a misdemeanor trial

courtroom should have an eight-person jury box with seating for six jurors and two alternates in comfortable swivel chairs. The jury box should also have a rail that is at least three feet from both the nearest attorney table and the rail separating the spectator area and the public.

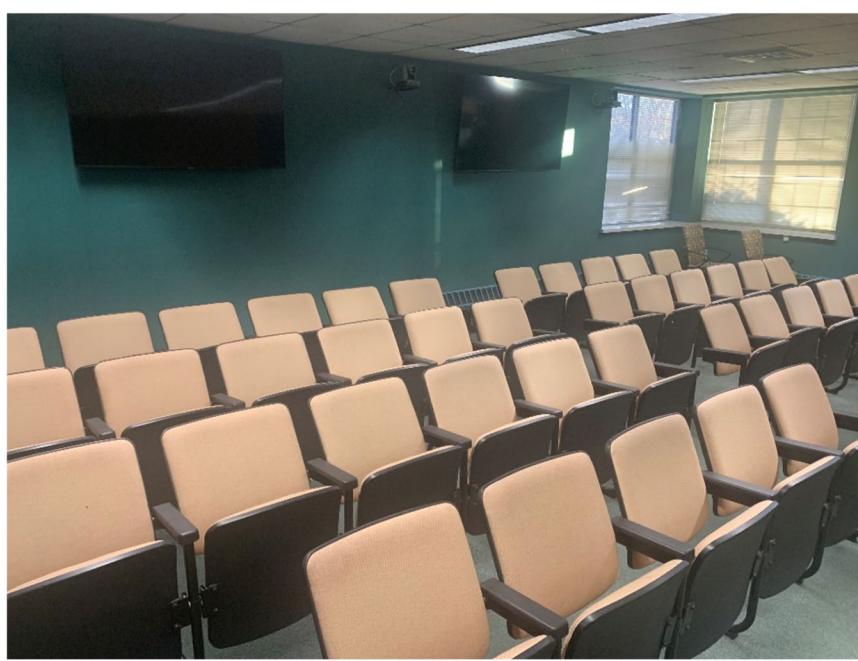
Figure 2- Rear of Courtroom

- NYS guidelines state that all public courtrooms should have two major functional areas: the well and the public area.

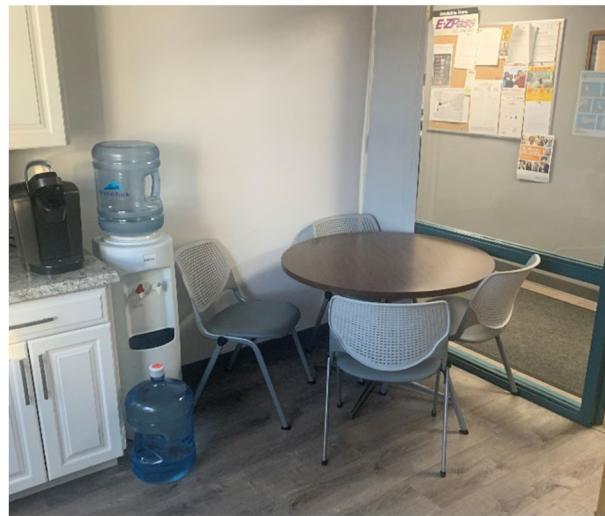
Figure 3 - Staff breakroom

- There are no designated facilities for jurors.
  - NYS Section 34.0 recommends that court facilities have a six person Jury deliberation room that is a minimum of 200 sq. ft. Both the Judge's Chamber and the staff breakroom that are sometimes used to host jury deliberations are inadequate.

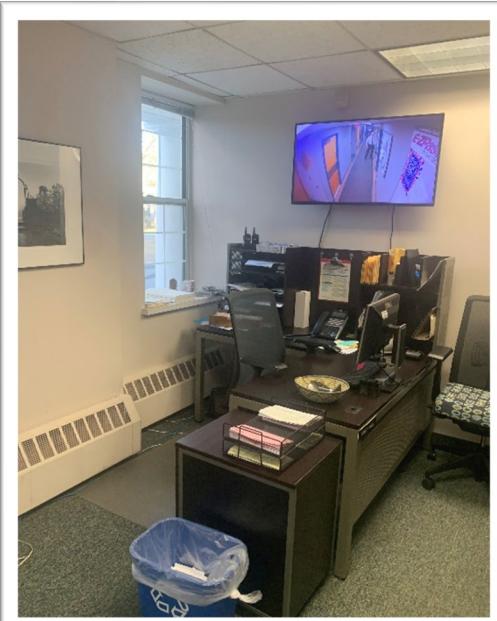
Figure 4 - Court Clerk's Office

- The Chief Clerk does not have their own office
  - Although there are currently only two clerks working in the clerical office space, they share one room. The chief clerk does not have their own office. NYS guidelines recommend that the chief clerk have a private office of at least 200 sq. ft.

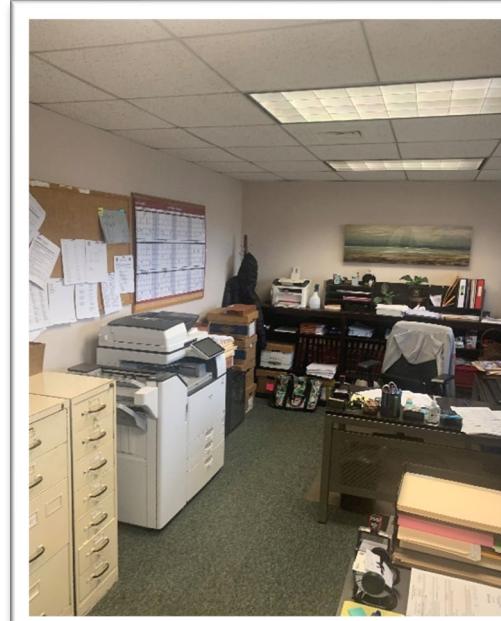
- Clerical staff should be able to access the court without crossing into public areas.
  - As noted above under Security, the clerks should be able to travel between their offices and the court room without going into public areas.
  - Court clerks collect fines and conduct other public facing transactions through a service window.

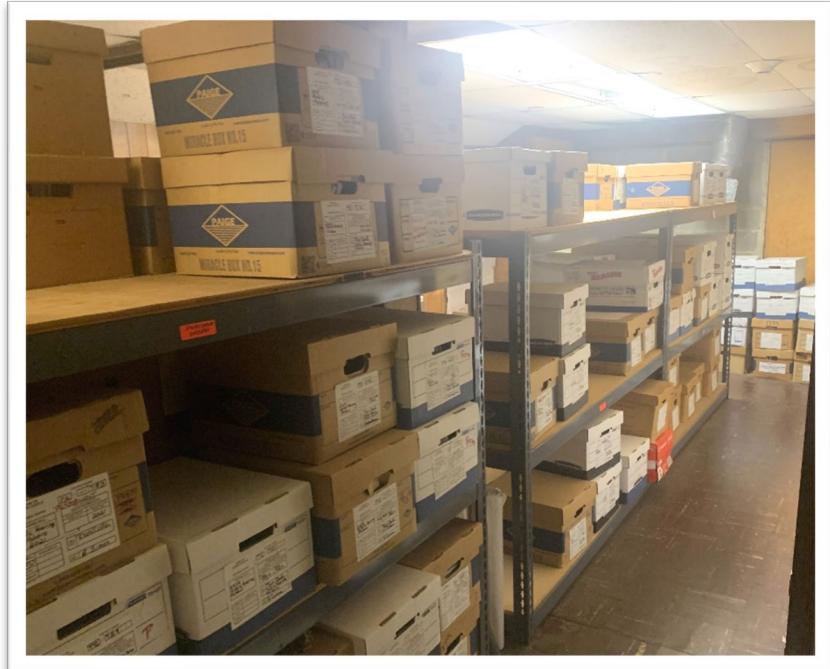
Figure 6- Attic Storage for court records

- There is limited storage space for the court files in the Clerk's Office
  - The court clerks have space only for a single year of case files in the office and must move all previous years files to an attic storage space or offsite storage

- Court records are kept in an attic area with minimal climate control.

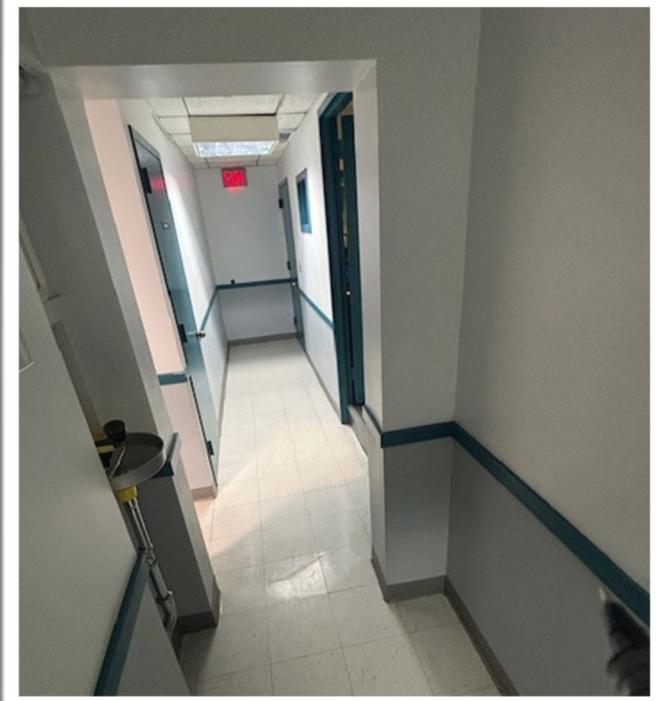
Figure 7 - Pinch point in hallway of police area

- Two people can not pass each other in the hallway without one turning to the side.
  - Audio privacy cannot be maintained if more than one person is on the phone in the detectives' or lieutenants' offices.

- Many hallways and spaces are narrow and would not be considered ADA accessible.
  - Spaces such as the locker rooms, police lobby, and hallways are very narrow and could not be easily used by persons using wheelchairs or other mobility aids.

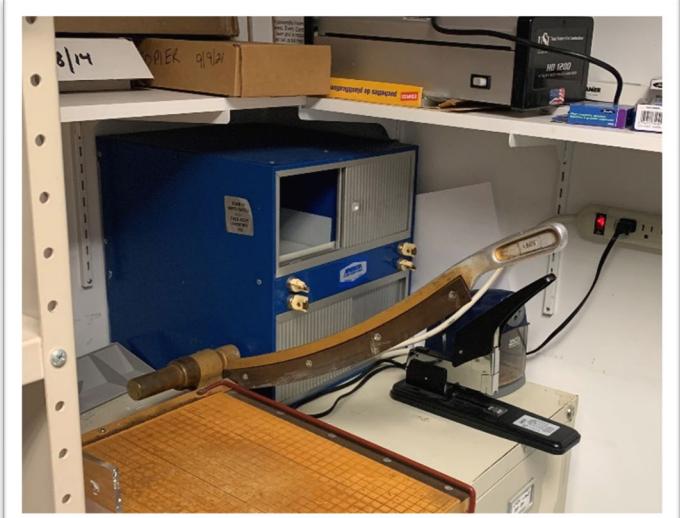
Figure 8 - Temporary firearm locker near processing

- Only one officer at a time can be in the sergeant's office to gather their necessary equipment.
  - The firearm temporary locker for the holding cell is located in the copier room twenty feet away.

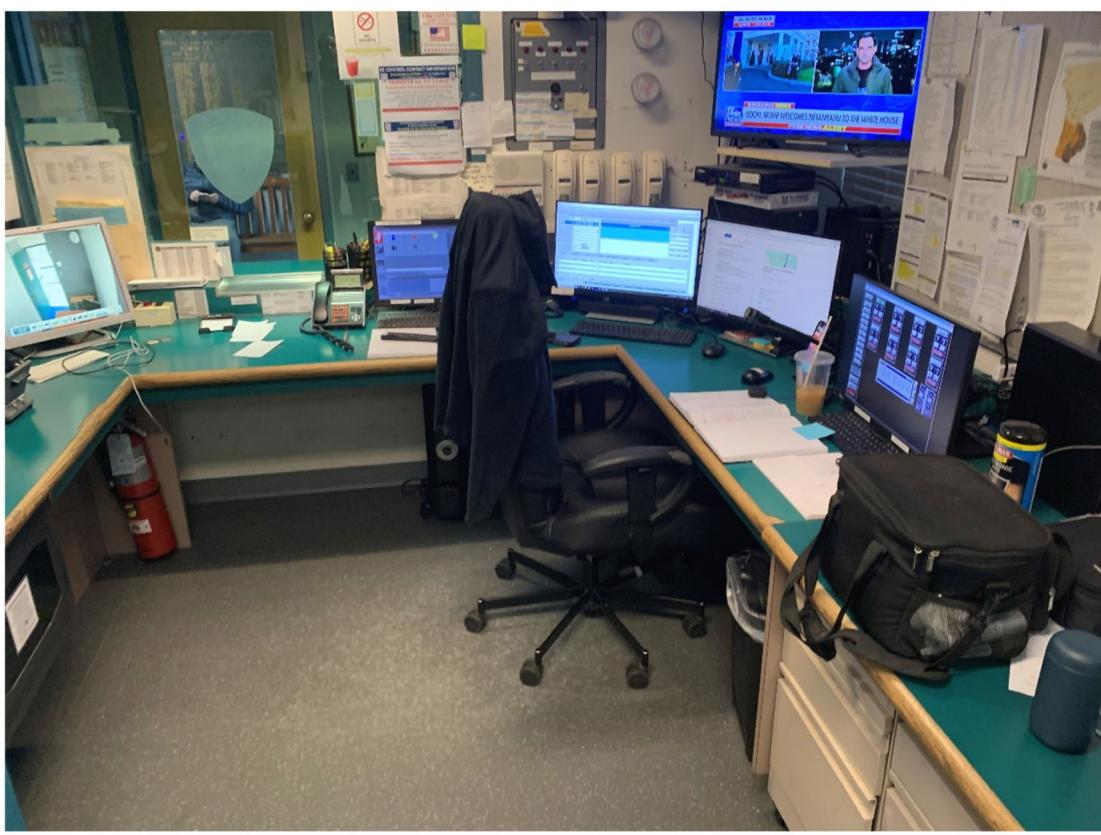
Figure 9 - Communications Desk

- **The communications desk's orientation is inefficient.**
  - Department staff have expressed the inadequacy of the communication's office layout. Because of the large window in the space, the monitors must be spread out amongst a desk which does not allow officers at the desk to work as efficiently as they could while working dispatch.
- **The communications office has bulletproofed glass, but the surrounding walls are not bulletproof.**
  - The large window in the communications office is bulletproofed; however, the surrounding walls are not. This poses a security concern.

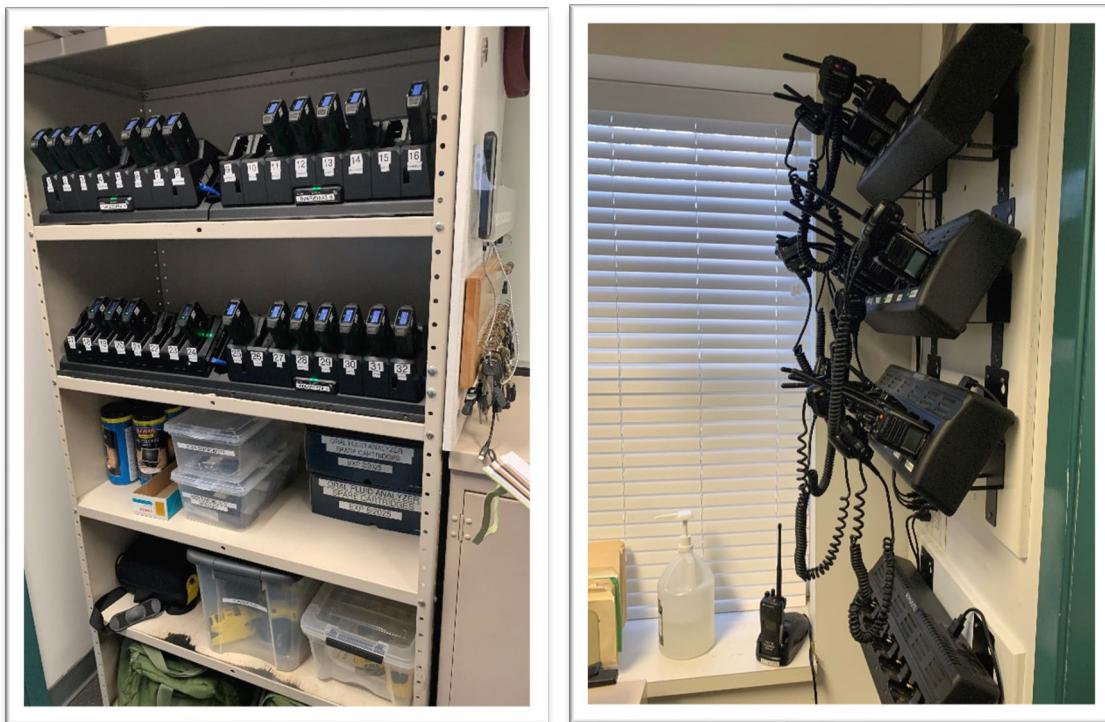
Figure 10 - Equipment in Sergeant's Office

- **The sergeants' office also holds all body cameras and several filing cabinets.**
  - While the sergeants' office is a decent size at 216 sq. ft., officer's body cameras are charged and stored there. There are also several filing cabinets that take up space in the office.
- **Patrol officers need to come into the office to get their equipment before their shifts.**
  - The necessary equipment includes the body worn cameras, TASERs, radios and vehicle keys.

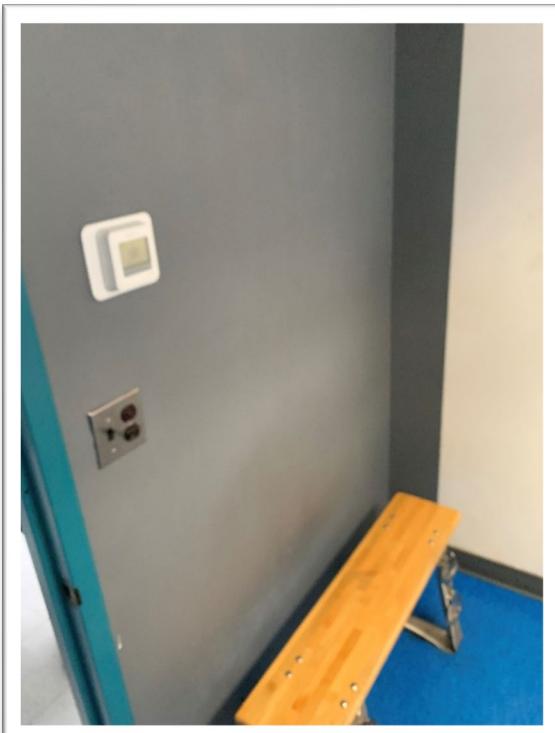
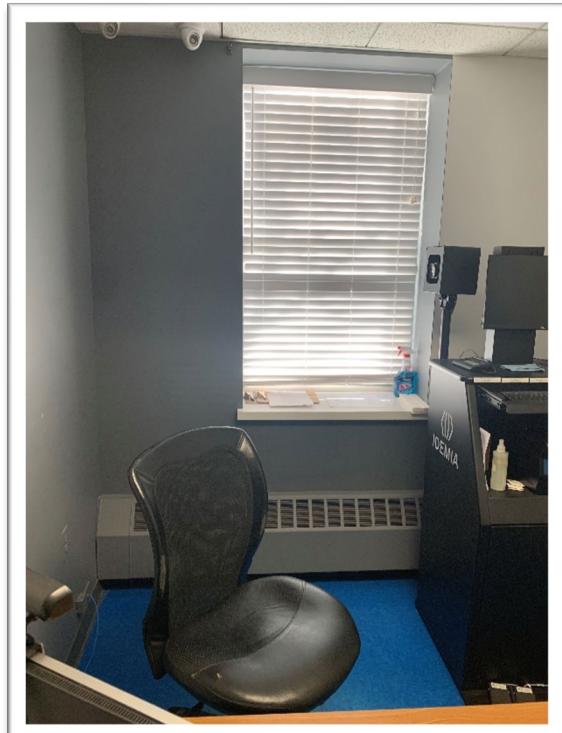
Figure 12 - Processing Room

- **The processing area adjacent to the holding cells is small at 57 sq. ft.**
  - Police department leadership expressed concern over the size of the processing area next to the holding cells. It was stated that the area is tight, and officers have gotten hurt while trying to process combative prisoners in the past.
- **The two holding cells are approximately 50 sq. ft.**

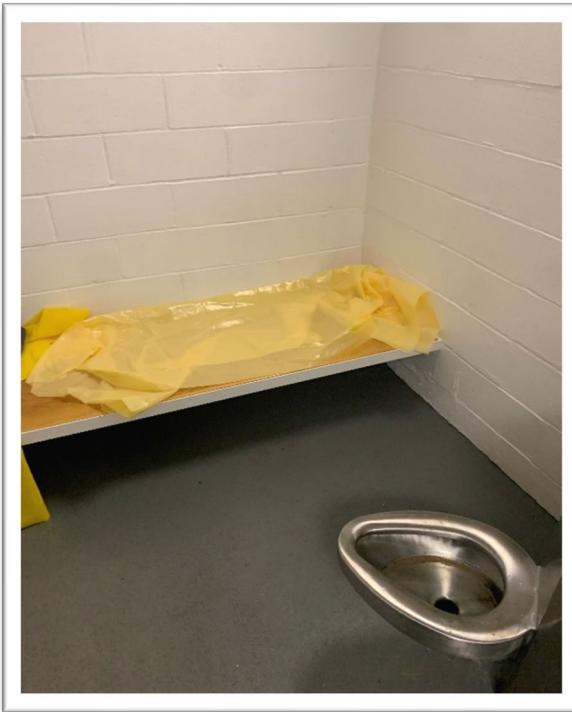
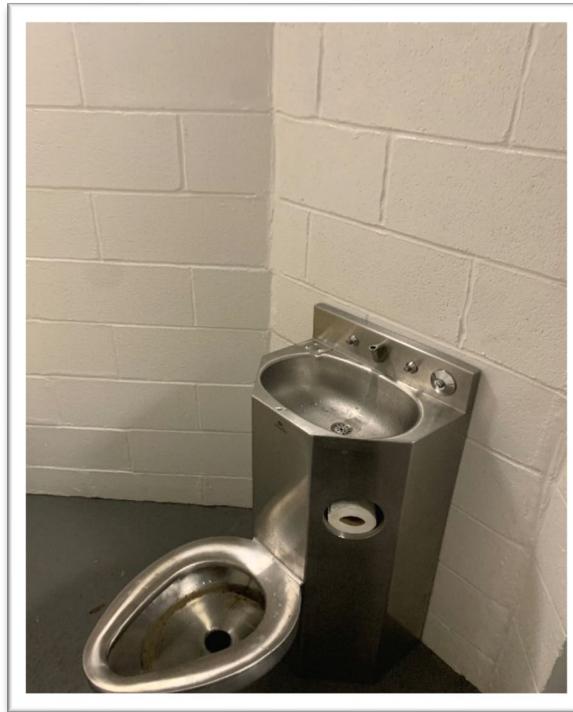
Figure 11 - Holding Cell

- There are two temporary holding cells in the police department. This would allow officers to separate incarcerated persons based on gender.
- The space meets the standards established by New York State for adults.

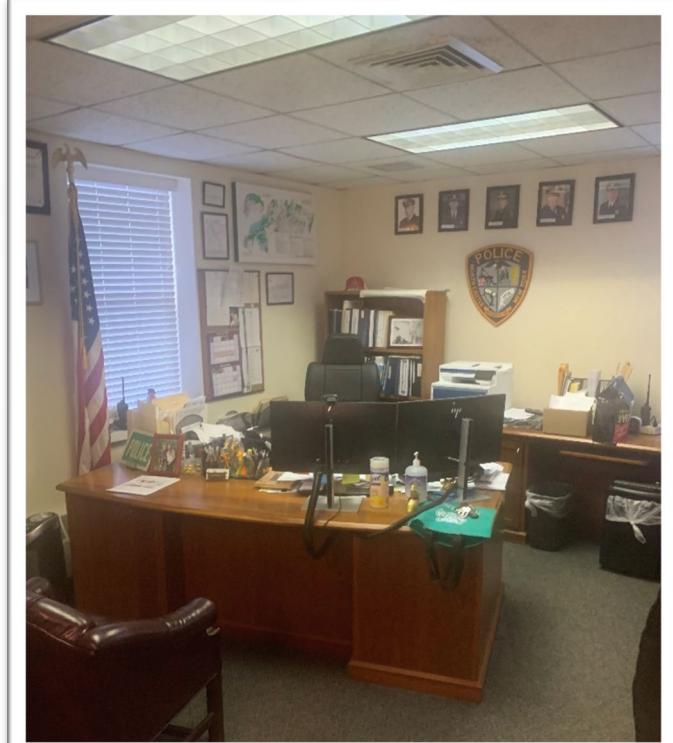
Figure 13 Chief's Office

- **The Chief's Office is relatively small and does not have storage space.**
  - The Chief's Office is 221 sq. ft. Much of the space is taken up by an executive desk and filing cabinets. There is a small closet in the Chief's Office, but it was expressed by department leadership that it is inadequate for storing uniforms, boots, and other belongings. There are no bathroom facilities.

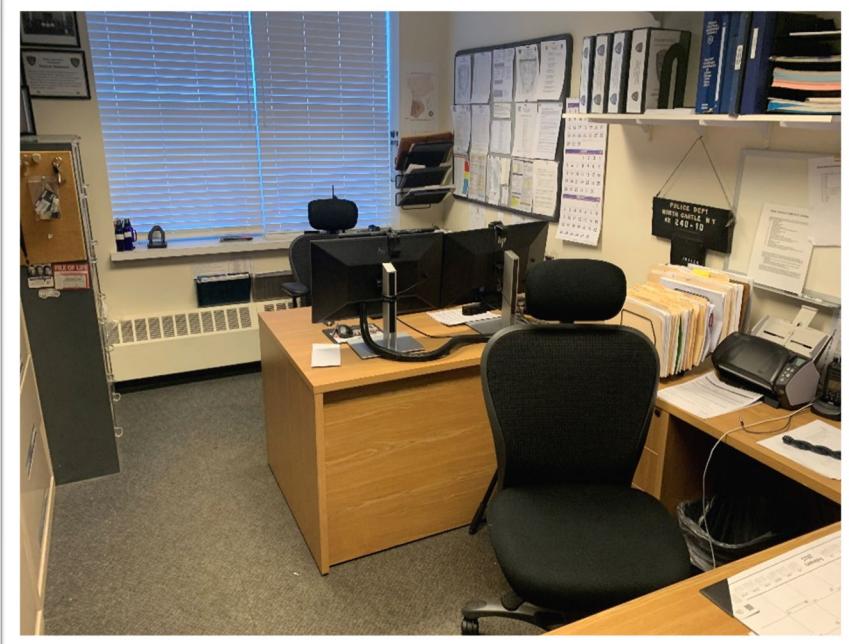
Figure 14 Lieutenants' Office

- The lieutenants' and detectives' offices are too small for the number of staff who work in them.
  - Two lieutenants share an office that is 148 sq. ft. and three detective staff share an office that is 213 sq. ft. Neither is adequate for the materials, audio privacy and tasks required of those personnel.

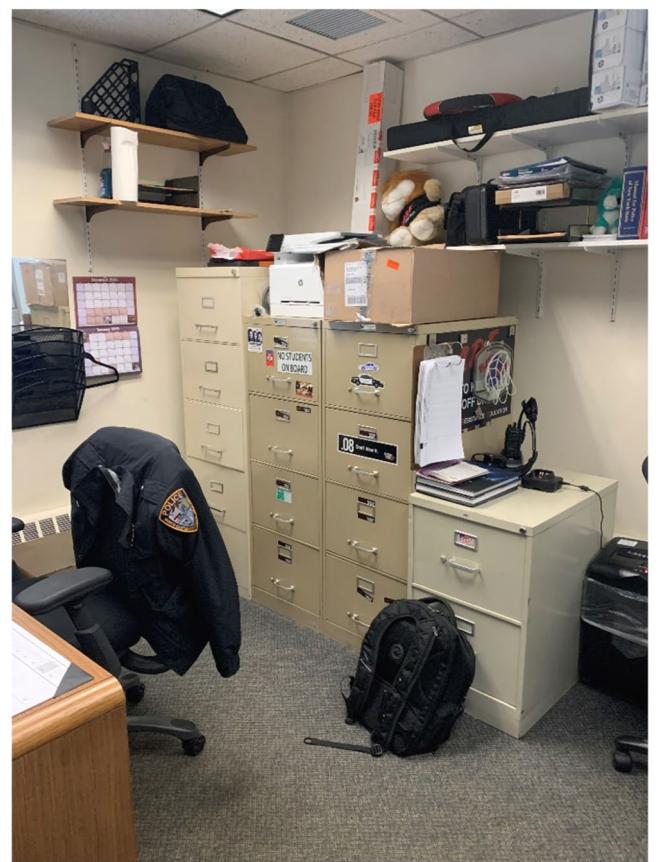
Figure 15 Juvenile Office

- The Juvenile Office is only 159 sq. ft.
  - Department leadership have expressed the need for the youth office to be located near an entrance of the department so that youth do not have to walk further into the department. This is required by New York State rules related to interviewing minors. The office is too small to be shared by two School Resource Officers and host youth, parents and others when necessary.

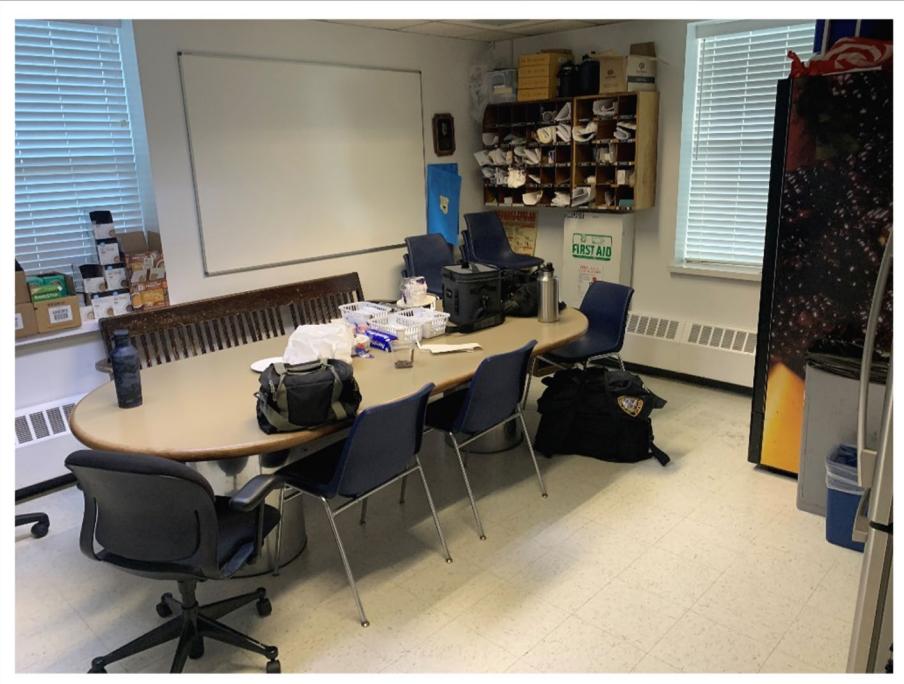
Figure 16 Break Room

The breakroom is located on the first floor and doubles as the Town's EOC. The breakroom comfortably sits about 6 officers which is enough for a shift. However, this space is also used for officers to write reports and the flat surfaces in the room can become a collection point for a variety of items.

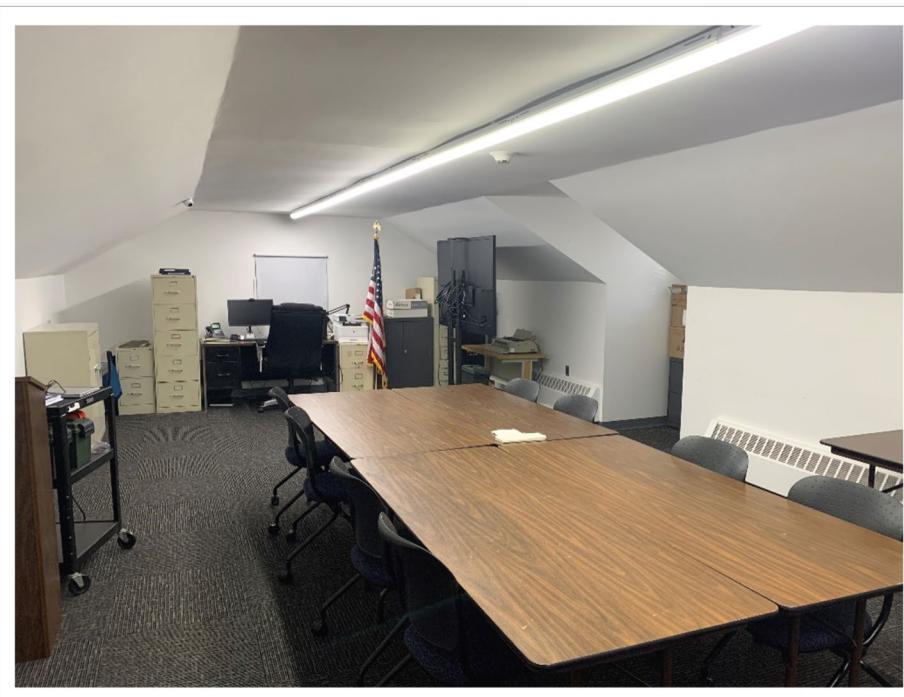
Figure 17 Training Room

- The attic training room is small and insufficient for hands-on training and large staff meetings.
  - Department staff have expressed that the training room is too small to do hands on training other than CPR and AED training. Because of gabled

ceilings in the space, only 15-20 chairs can fit in the space which is not enough for certain necessary staff meetings.

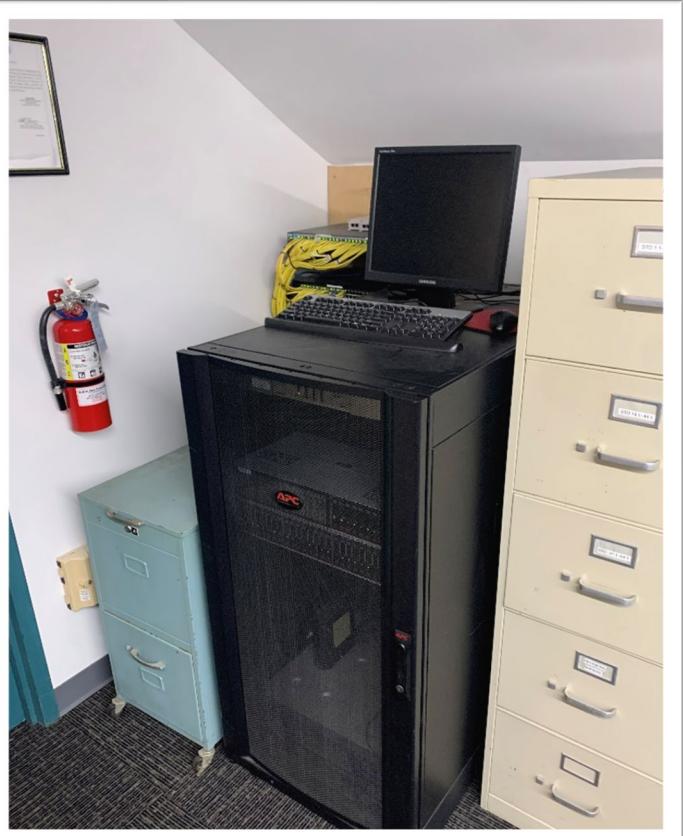
Figure 18 Police Server

- The primary police server is kept in the training room.
  - A recommended practice would be for the server to be kept in a secured, climate-controlled closet with a redundant power supply.

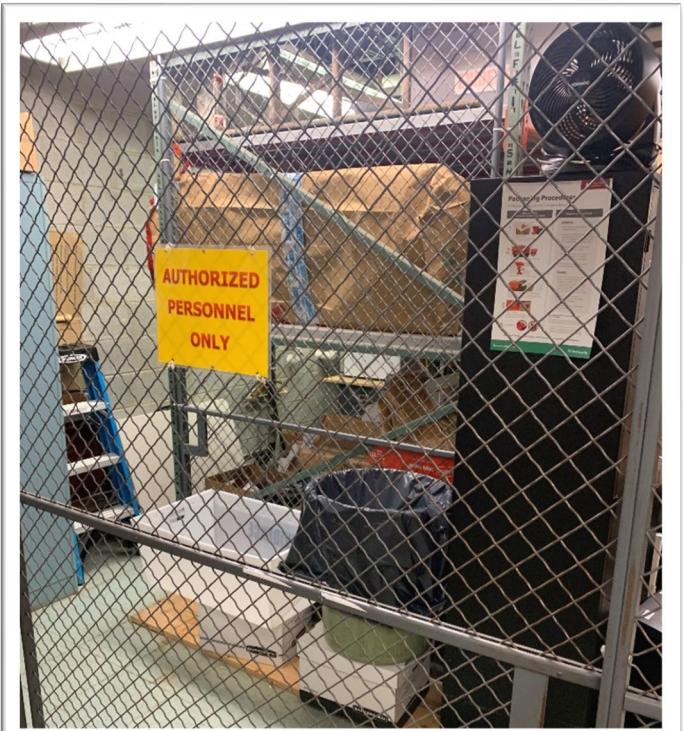
Figure 19 Evidence Locker

- The space for evidence is small and insufficient at 348 sq. ft.
  - While the department has made the best of the space they have available for evidence, the space is small and does not have any real climate control or dehumidification.

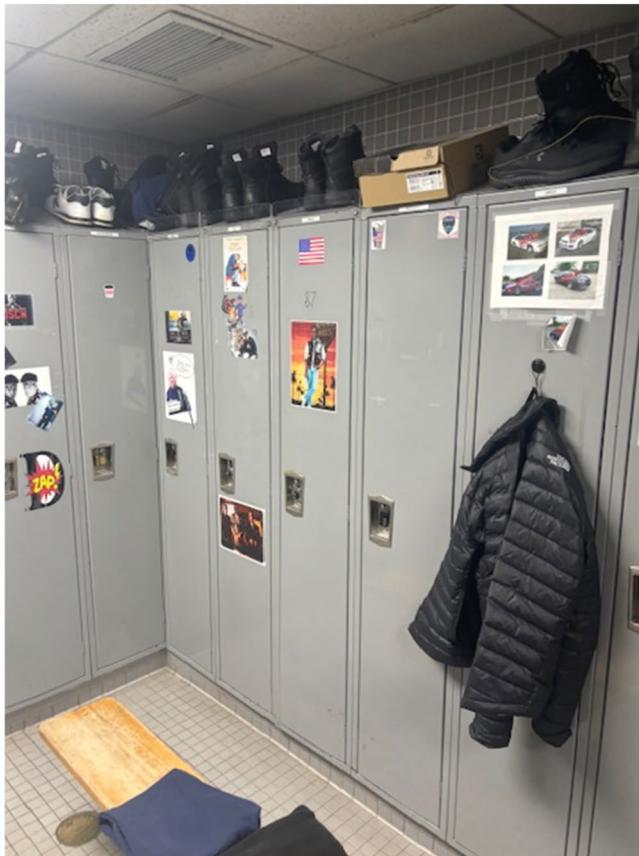
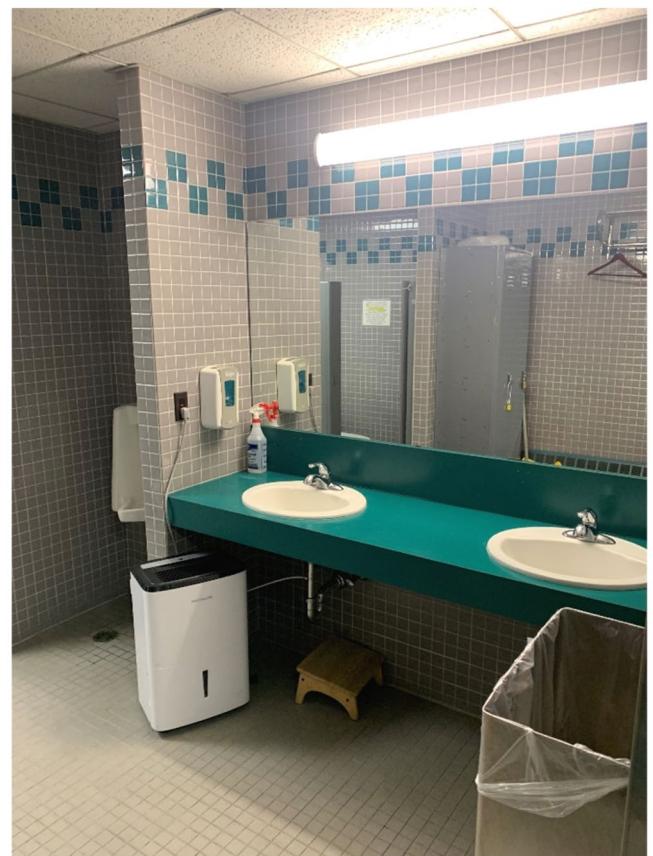
Figure 20 - Views of Men's Locker Room

- Boots are kept on top of the lockers to prevent them from getting wet if a sewer backup reoccurs.
  - The lockers are nearly forty years old and do not have any ventilation in them.

- **There is poor ventilation in the men's locker room.**
  - Department staff have stated that the locker room gets humid and there is not proper ventilation in the locker room.

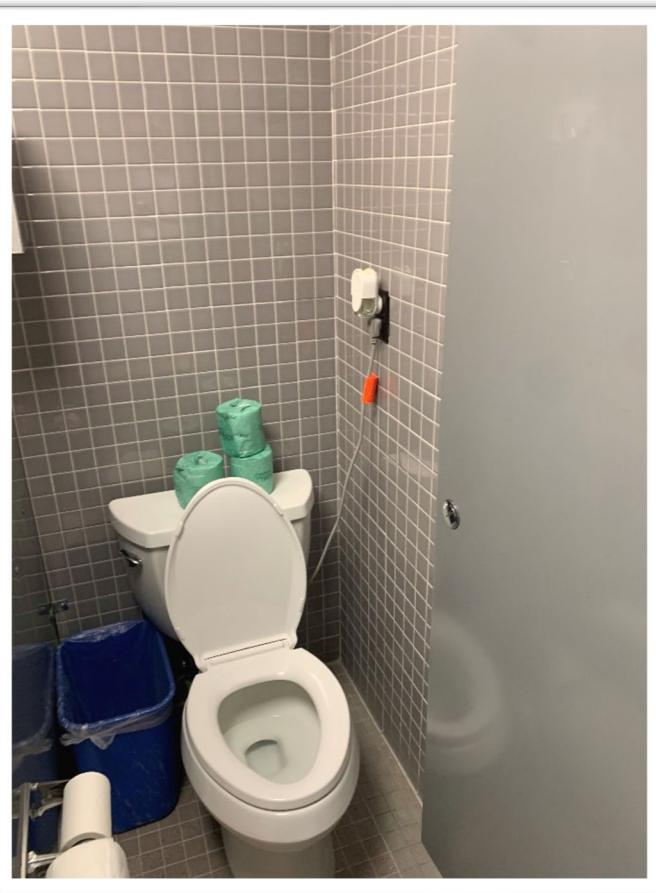
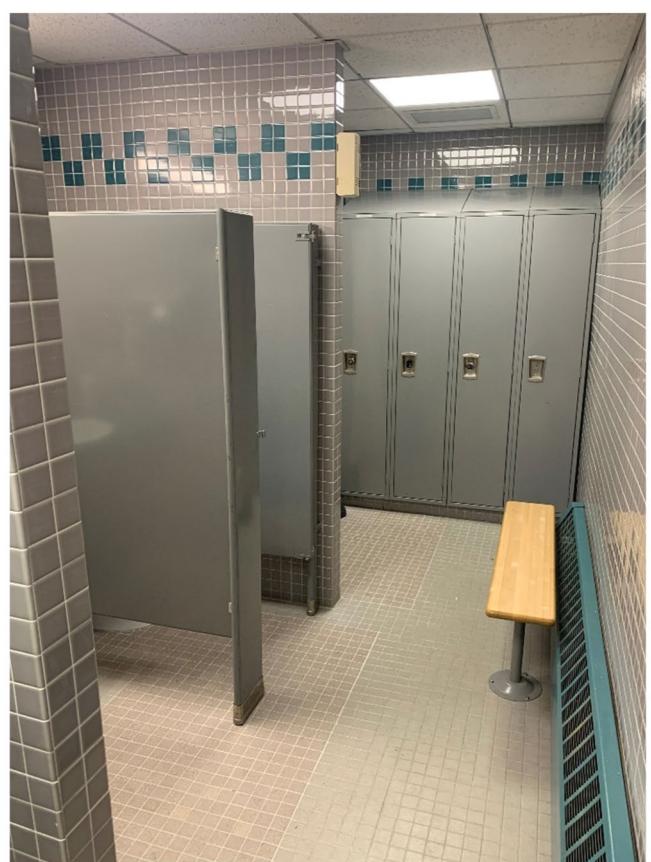
Figure 21 Views of Women's Locker Room

- **There are only four 16-inch-wide lockers in the women's locker room**
  - While there are only two female officers at the moment, the North Castle Police Department hopes to hire more in the future. The size of the current locker room would make it difficult to add any more female officers since all four lockers are currently used by the two current officers.
- **There is poor ventilation in the women's locker room.**
  - Department staff have stated that the locker room gets humid and there is not proper ventilation in the locker room. In an effort to combat the humidity, a residential grade dehumidifier is plugged into an outlet in the toilet stall with its cord running behind the toilet.
- **The lighter gray tile indicates the sections of the floor that were excavated as part of an effort to ameliorate a recurrent wastewater flooding problem.**

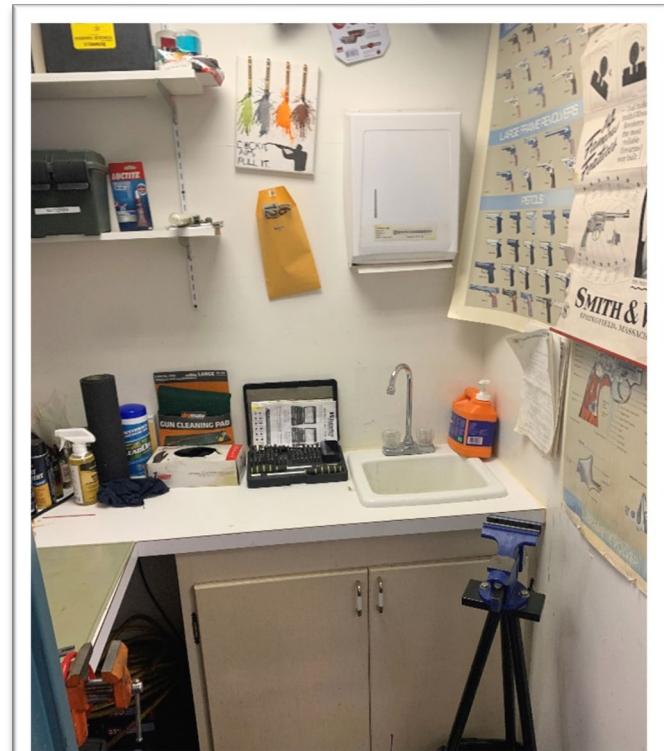
Figure 22 - Armorer's Closet

- The armory lacks sufficient space to conduct its work.
  - The armorers in the department operate out of a converted broom closet and use a folding wooden shelf in the hallway to service and maintain the firearms.

- The space used to store ammunition and firearms is inadequate.
  - Currently, firearms and ammunition are kept in homemade wooden cabinets with hollow wood doors. These cabinets are not very secure and the space where these cabinets are located is small and insufficient for the department's needs.
- Firearms and ammunition are kept in the basement and some rifles are stored in the copy room on the first floor.

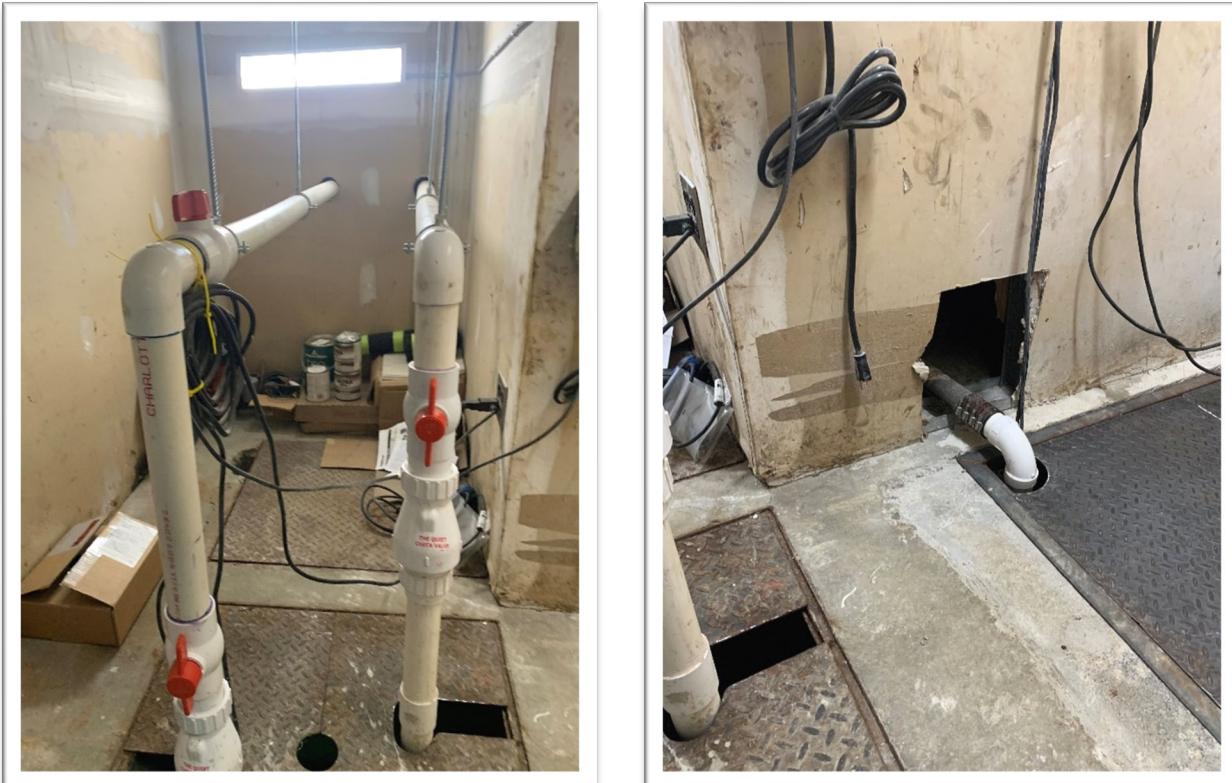
Figure 25 Pumps and pipes in basement

The basement near the locker rooms contains a subsurface pit that collects groundwater that is nearly continuously pumped out of the building. The area also contains wastewater pumps that are used to pump the wastewater up above the locker rooms and then out to collection main. These pumps have been the source of flooding issues in the past.
