# *Brynwood Golf & Country Club*

568 Bedford Road  
Town of North Castle  
Westchester County  
New York

## VIII. APPENDIX

## **APPENDIX L**

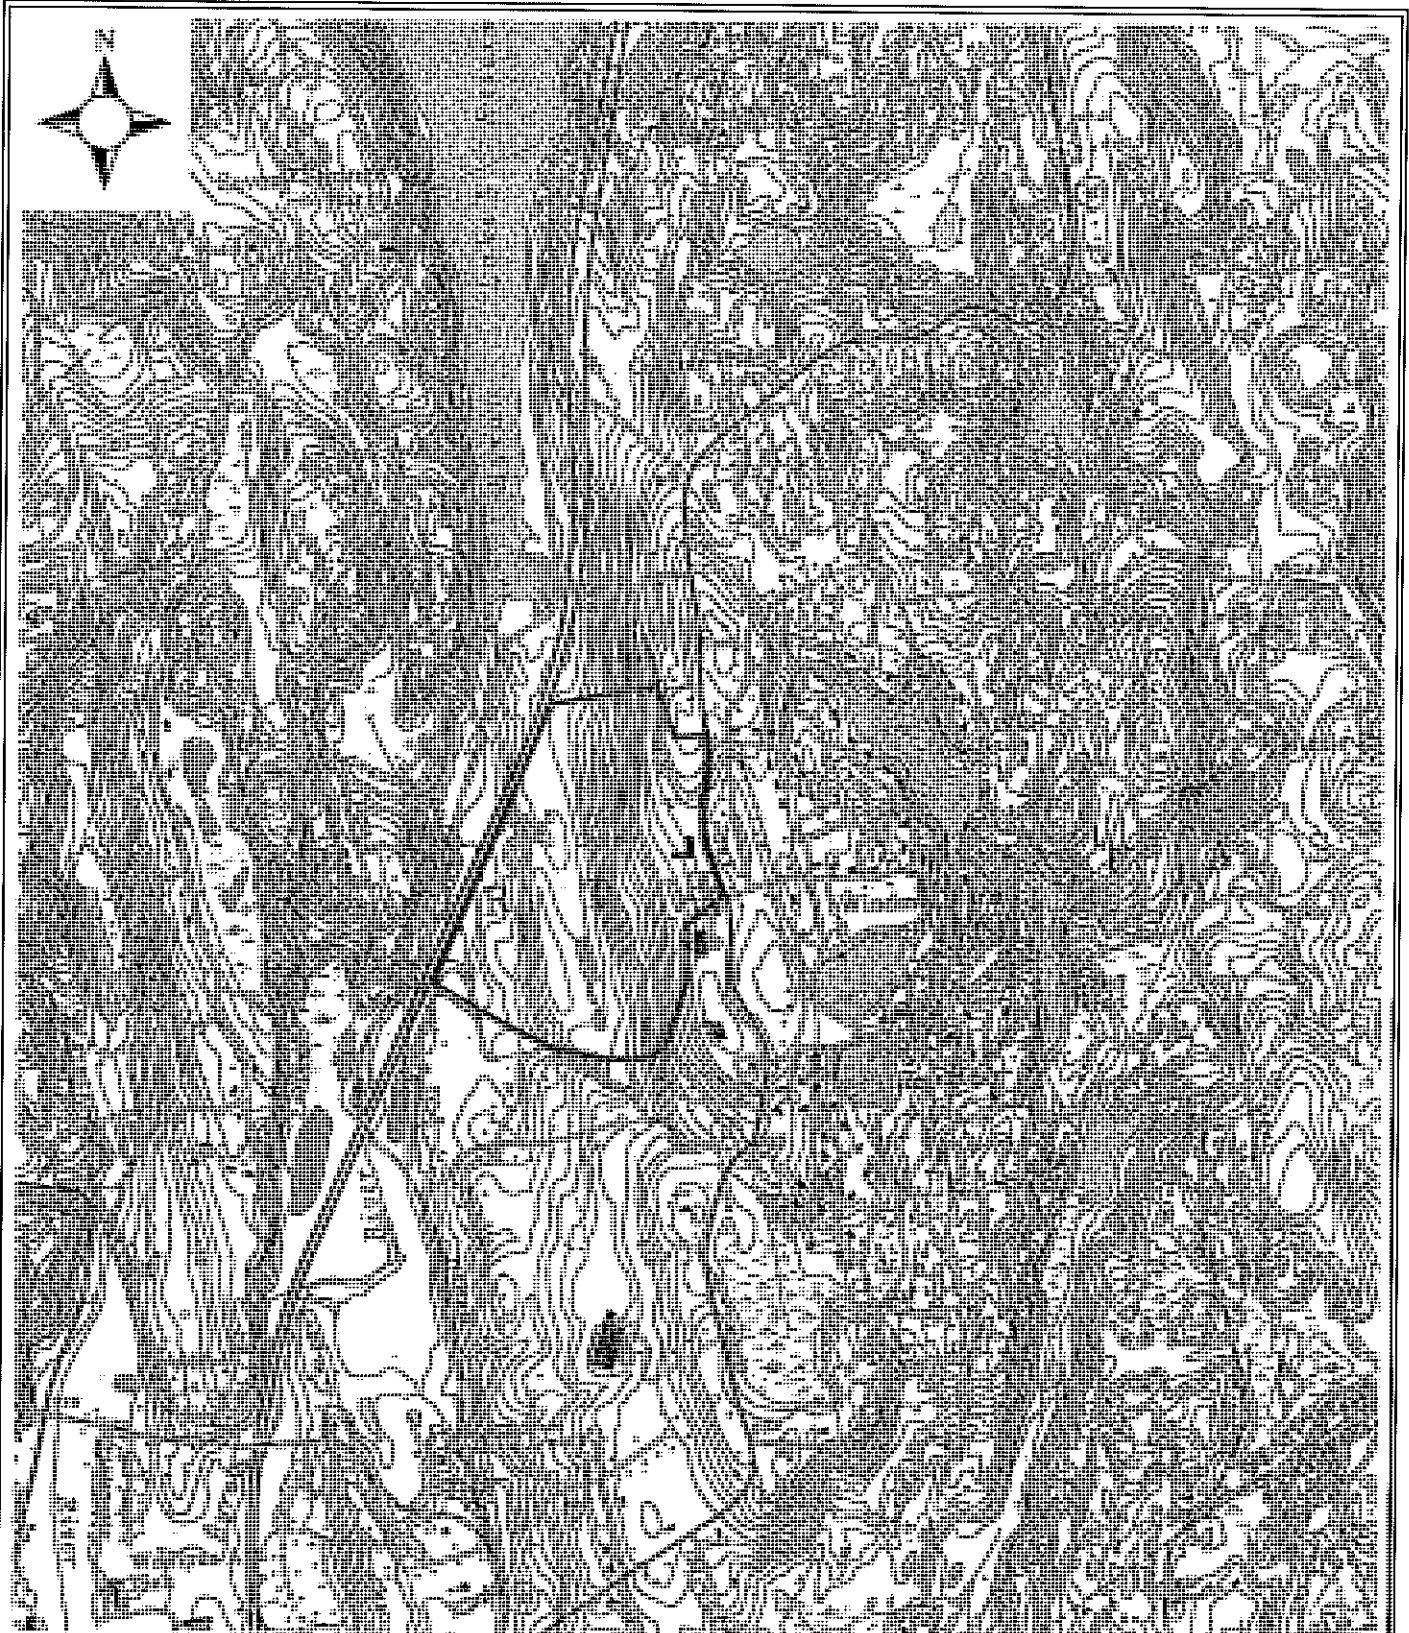
Source: U.S. Department of Interior Geologic Survey Topographic Map of the Mount Kisco, NY-Conn. Quadrangle, dated 1955 (photoinspected 1975 and photorevised 1971)

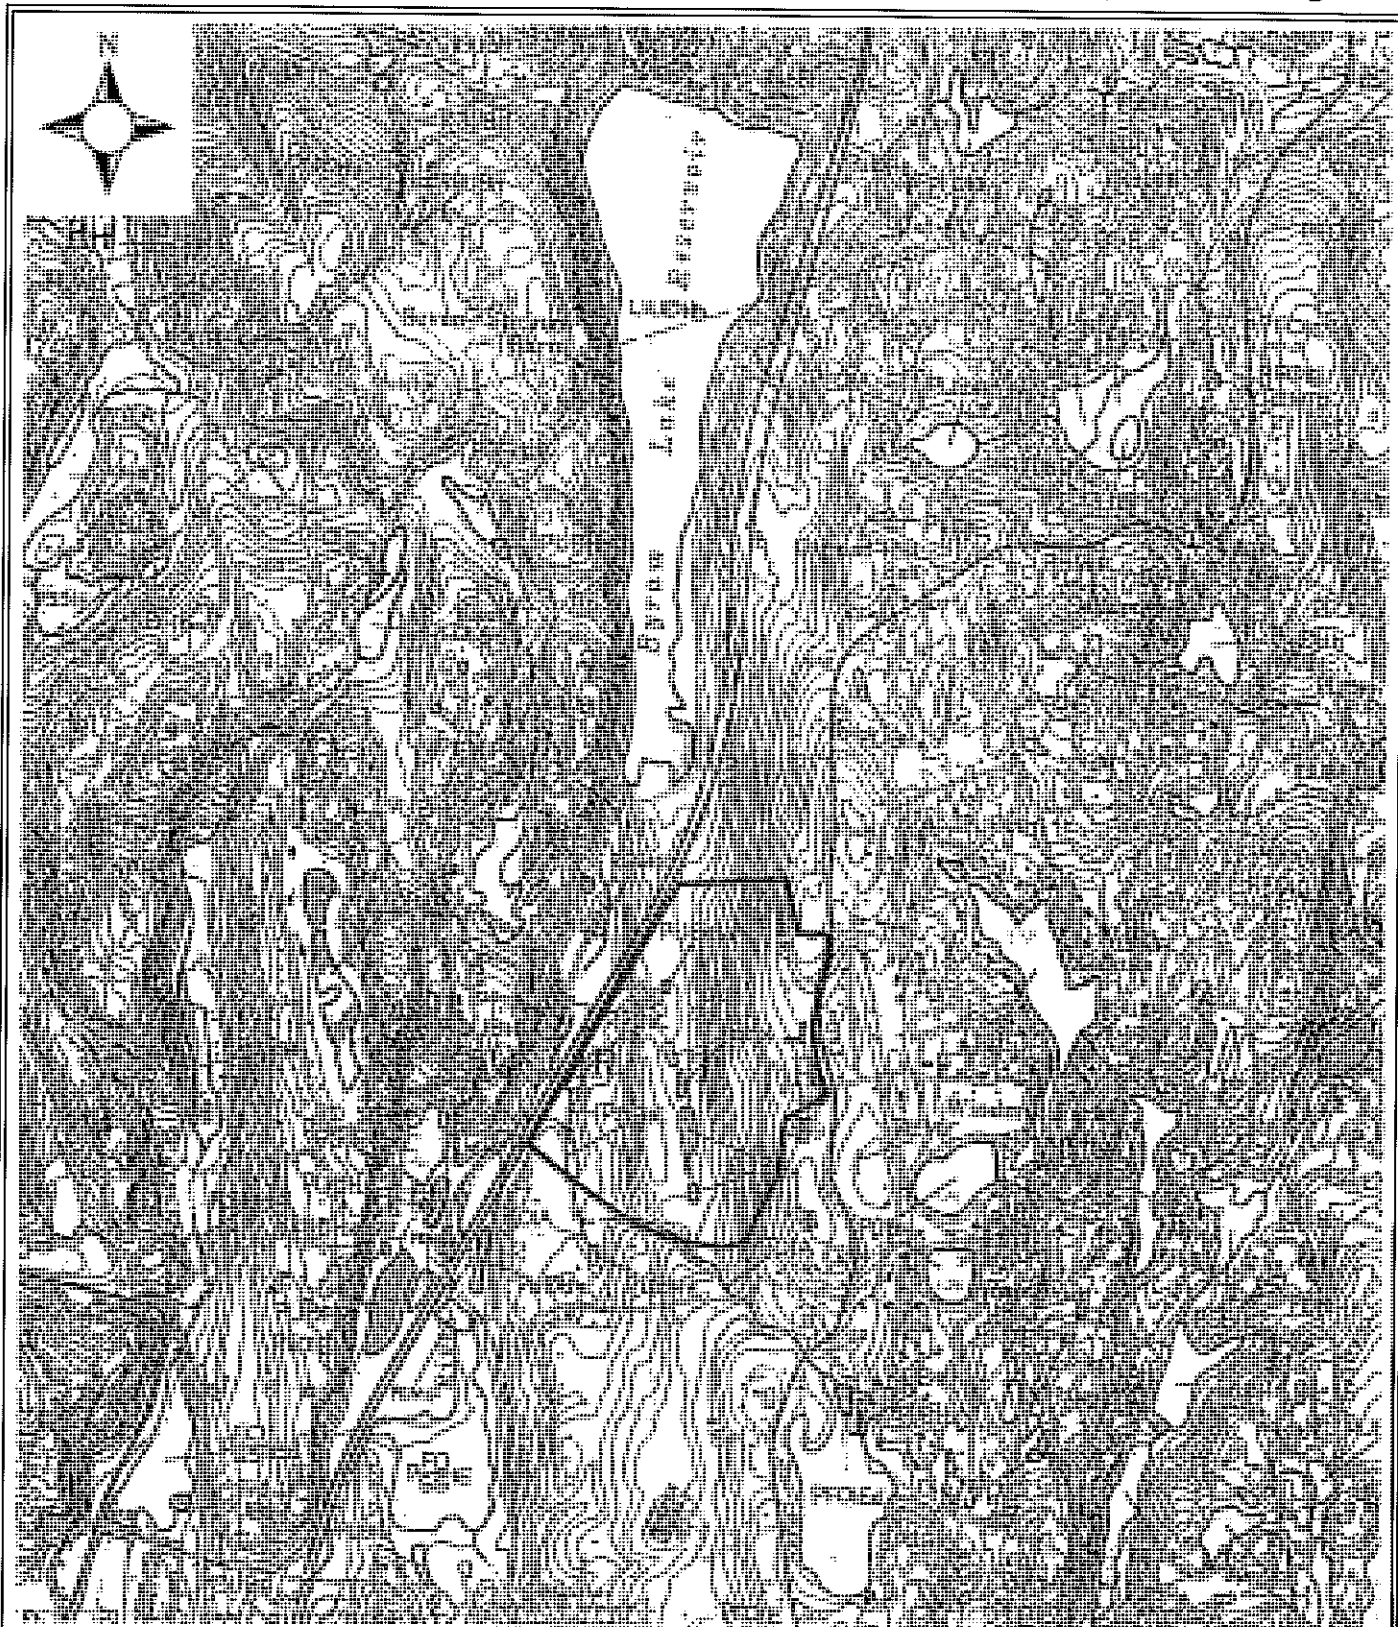
Source: U.S. Department of Interior National Wetlands Inventory Map of the Mount Kisco, NY-Conn. Quadrangle, dated March 1984

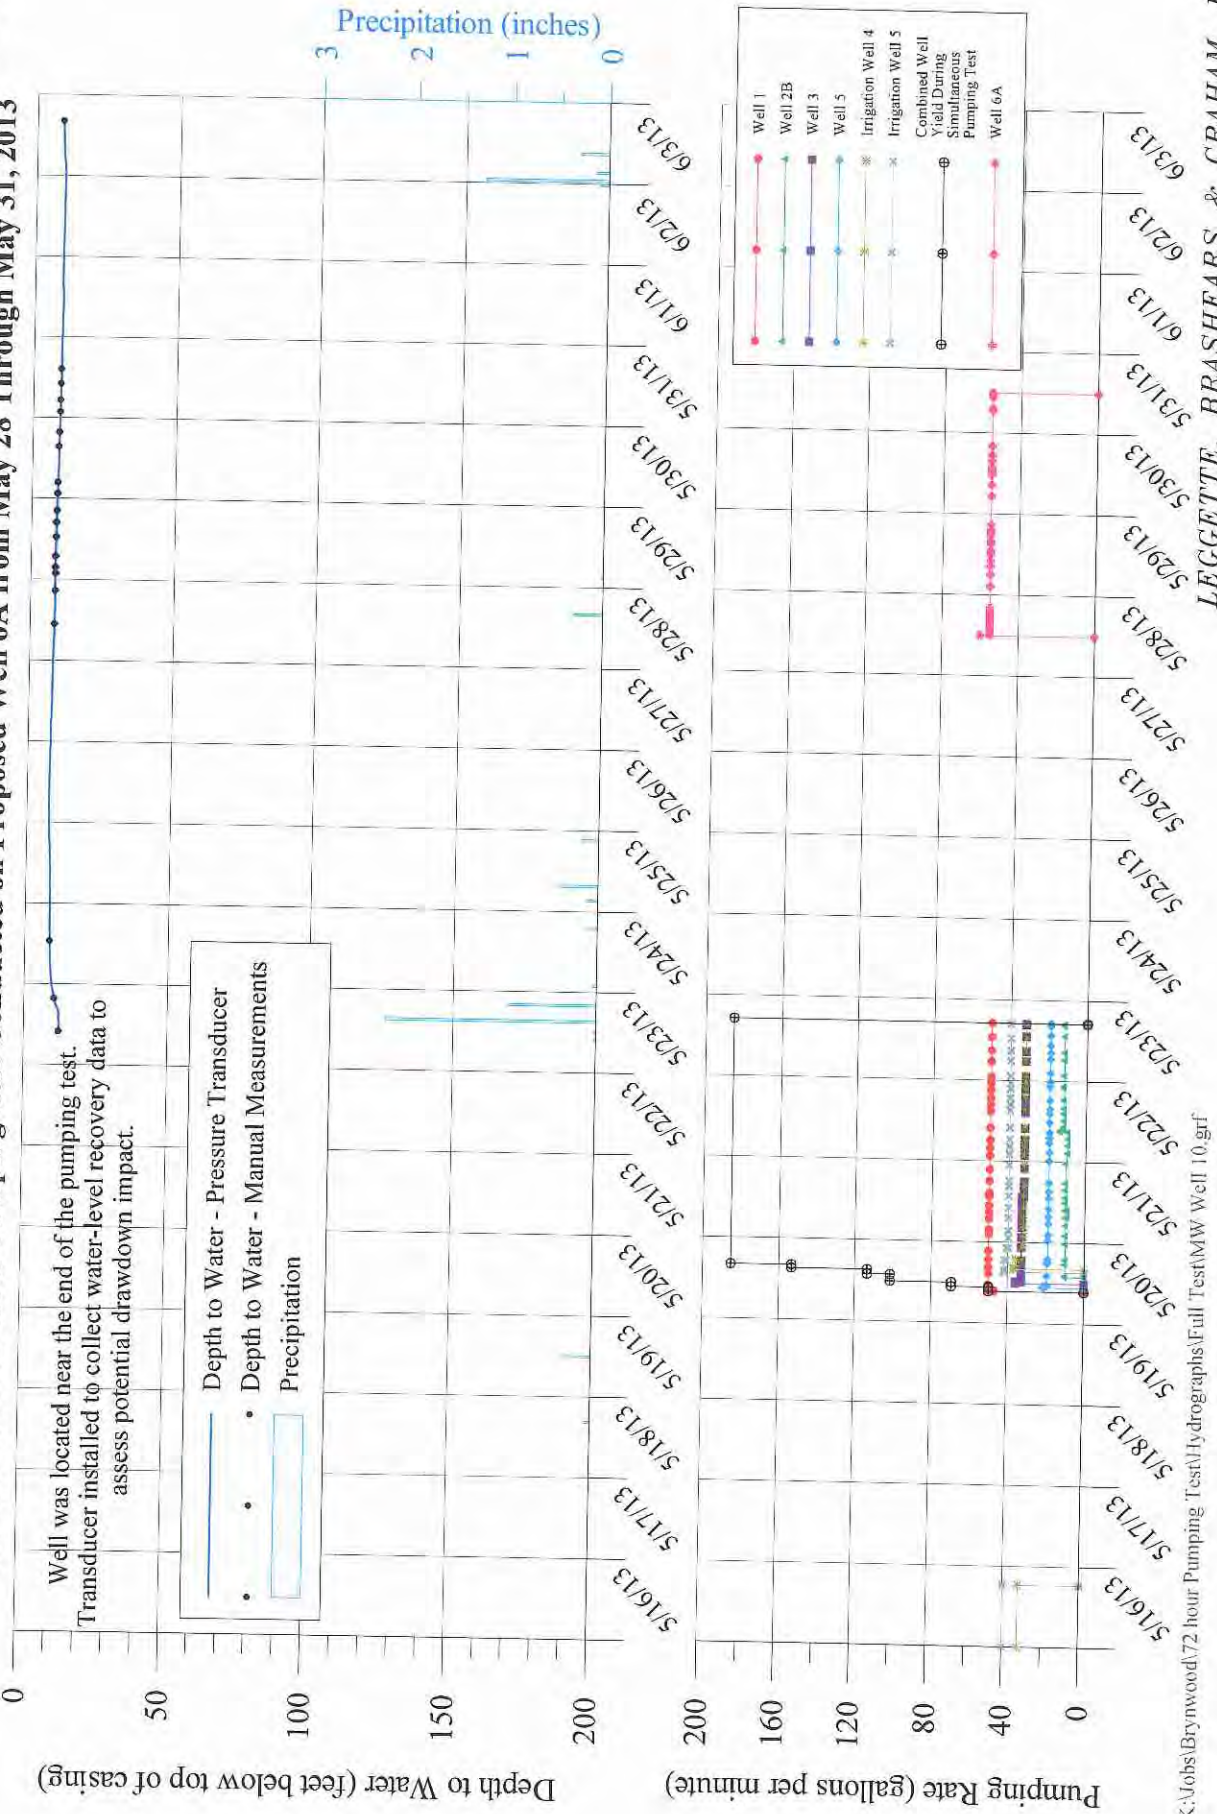
**Hydrograph of Water-Level Measurements Collected from Onsite Monitoring Well 10 During the Simultaneous Pumping Test Conducted on Proposed Wells 1, 2B, 3 and 5 and Existing Irrigation Wells 4 and 5 from May 20 Through May 23, 2013 and During the Individual 72-Hour Pumping Test Conducted on Proposed Well 6A from May 28 Through May 31, 2013**

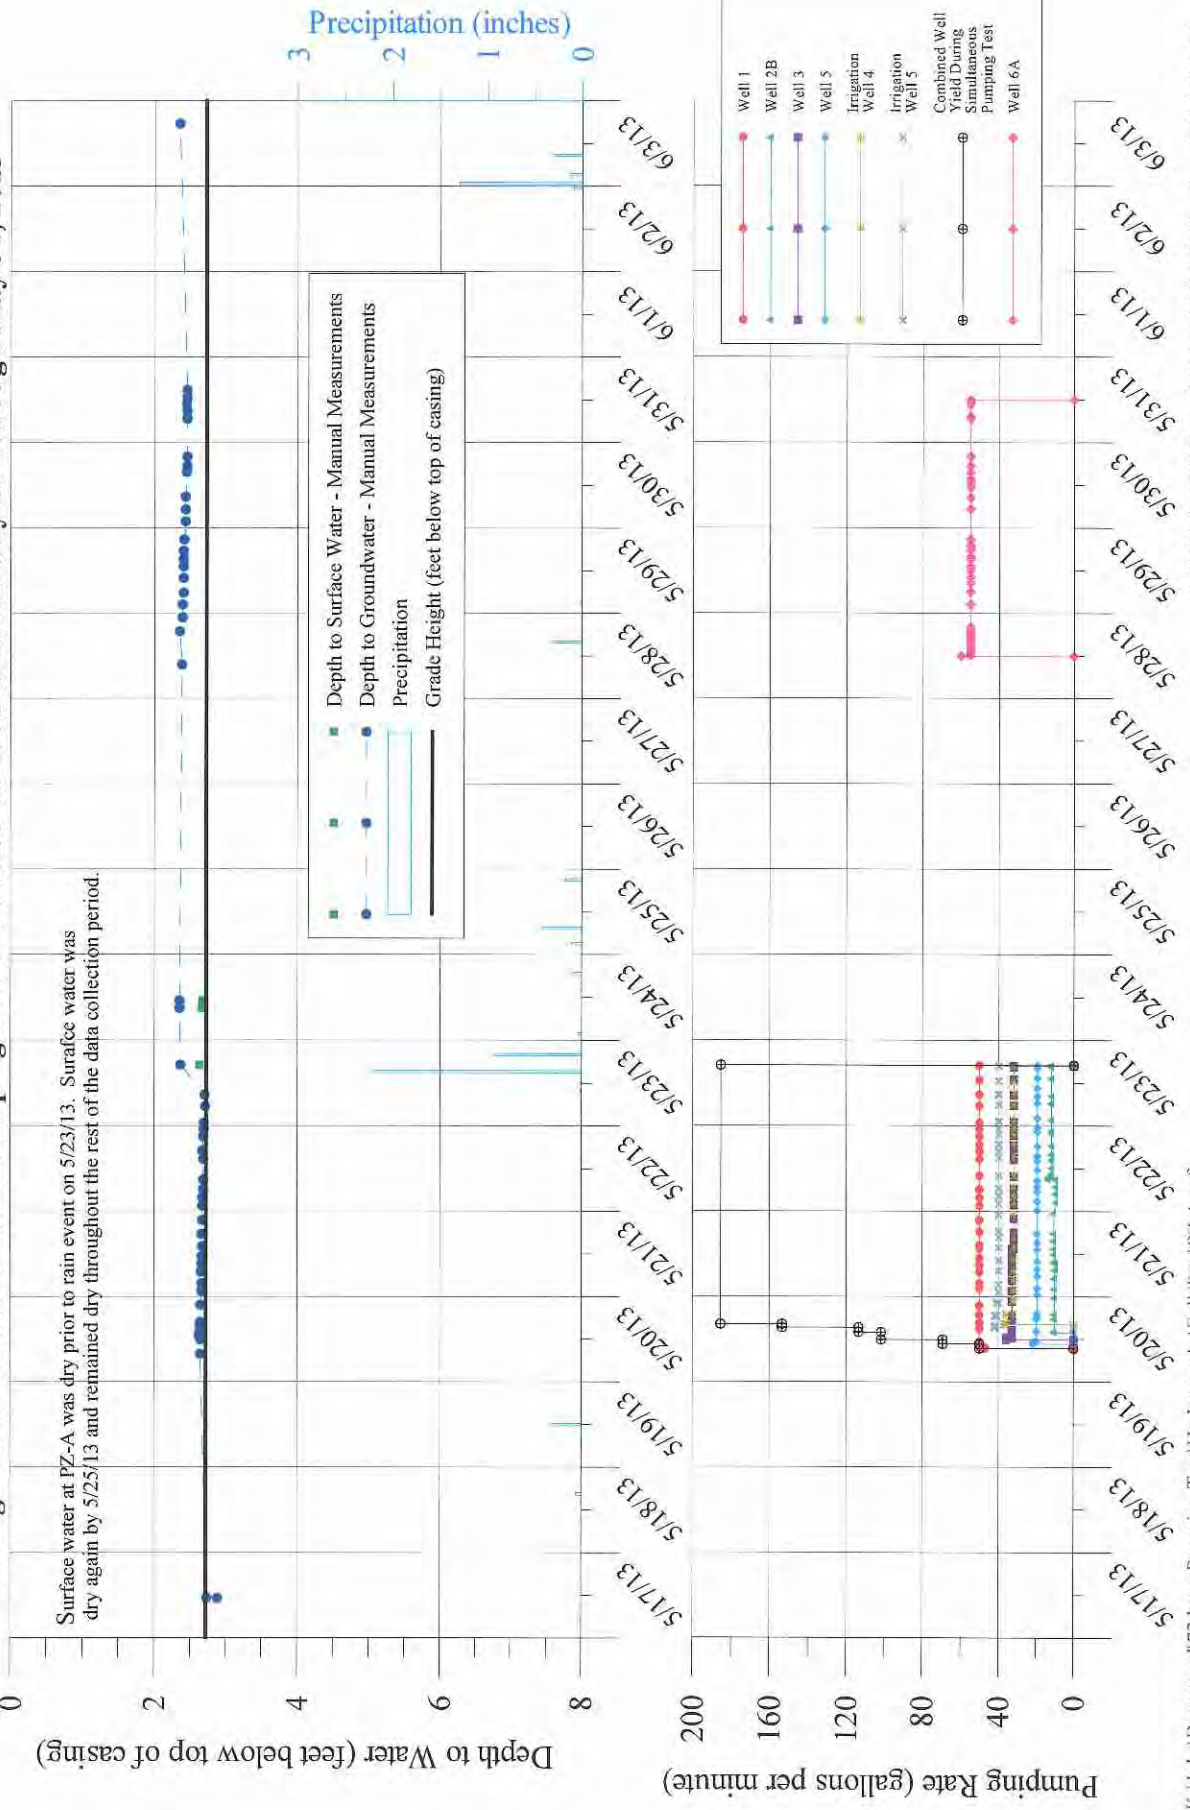
Surface water at PZ-A was dry prior to rain event on 5/23/13. Surface water was dry again by 5/25/13 and remained dry throughout the rest of the data collection period.

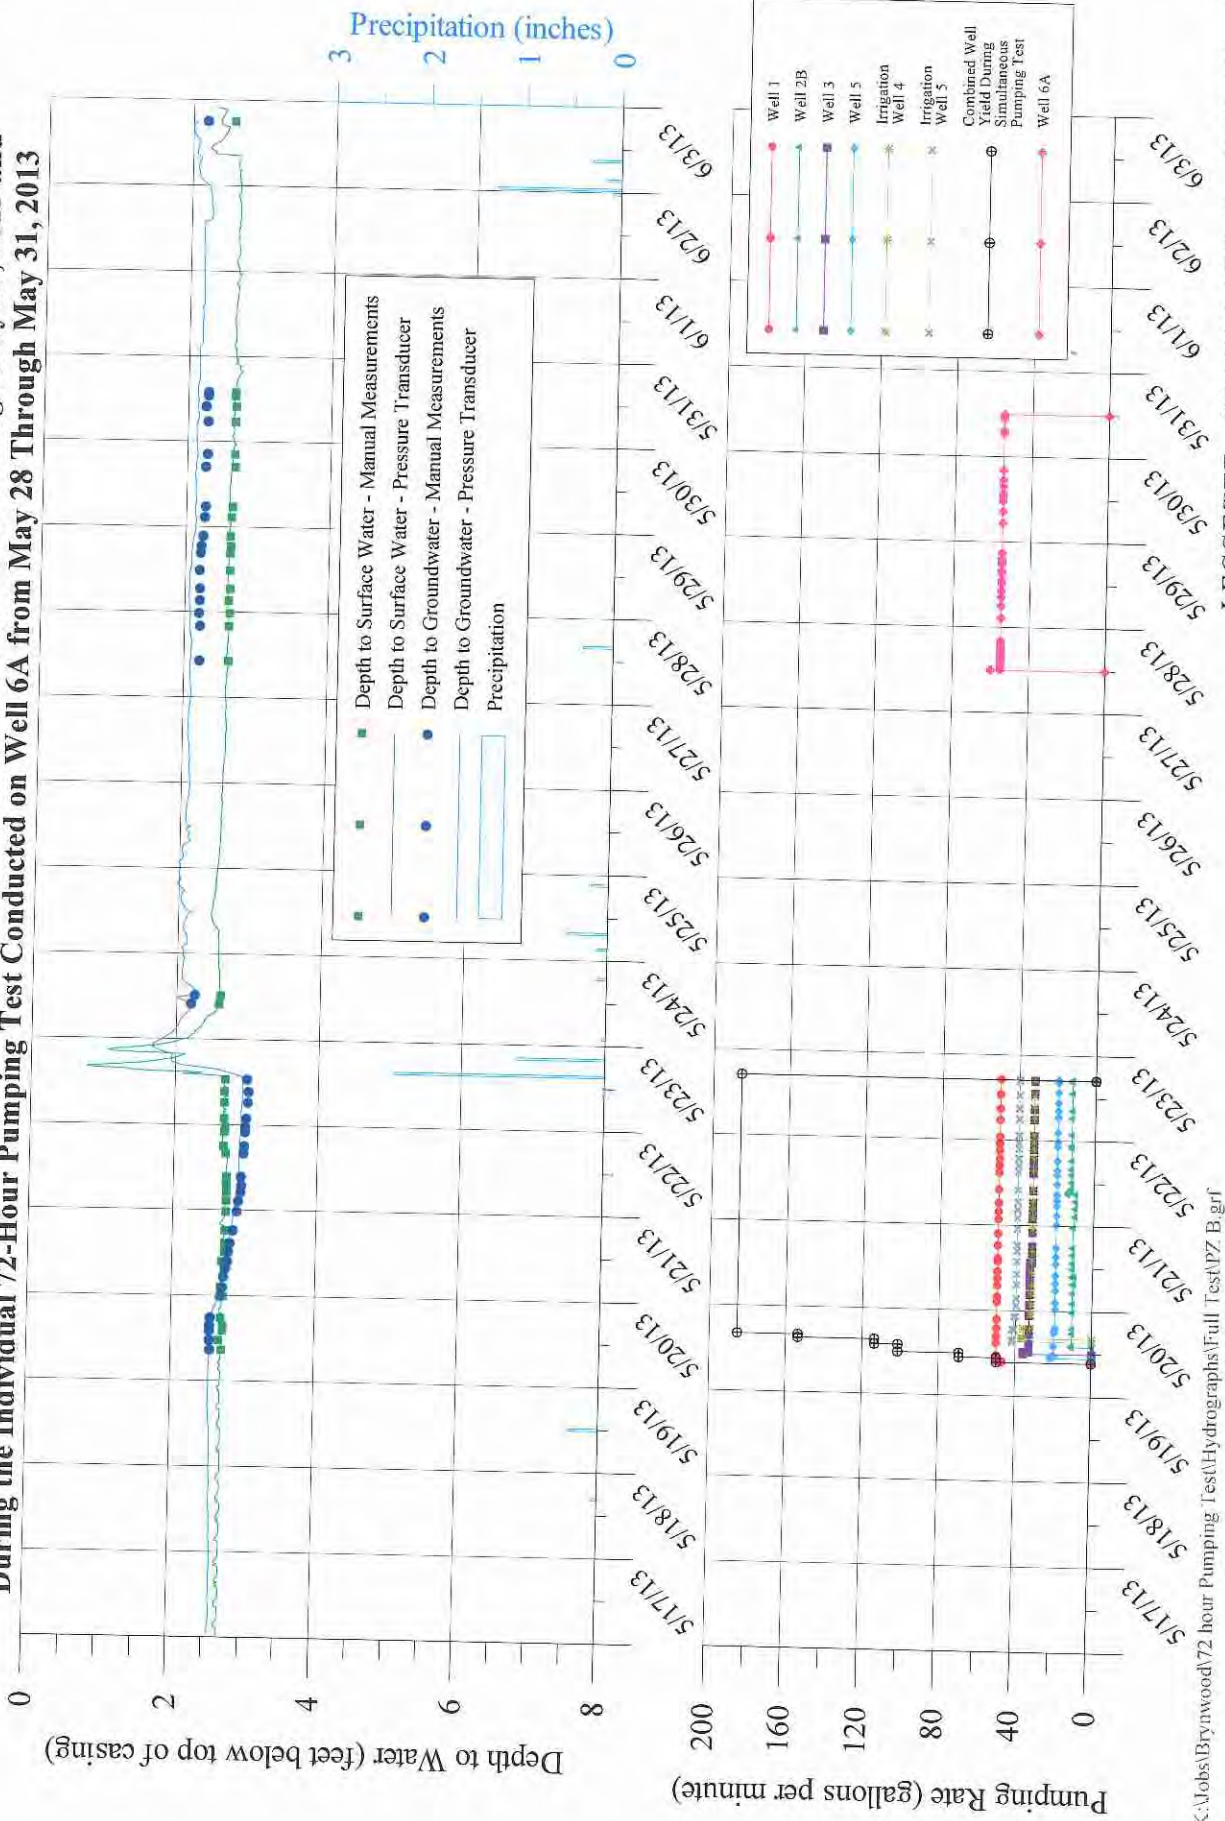
**Hydrograph of Water-Level Measurements Collected from Piezometer PZ-B During the Simultaneous Pumping Test Conducted on Proposed Wells 1, 2B, 3 and 5 and Existing Irrigation Wells 4 and 5 from May 20 Through May 23, 2013 and During the Individual 72-Hour Pumping Test Conducted on Well 6A from May 28 Through May 31, 2013**

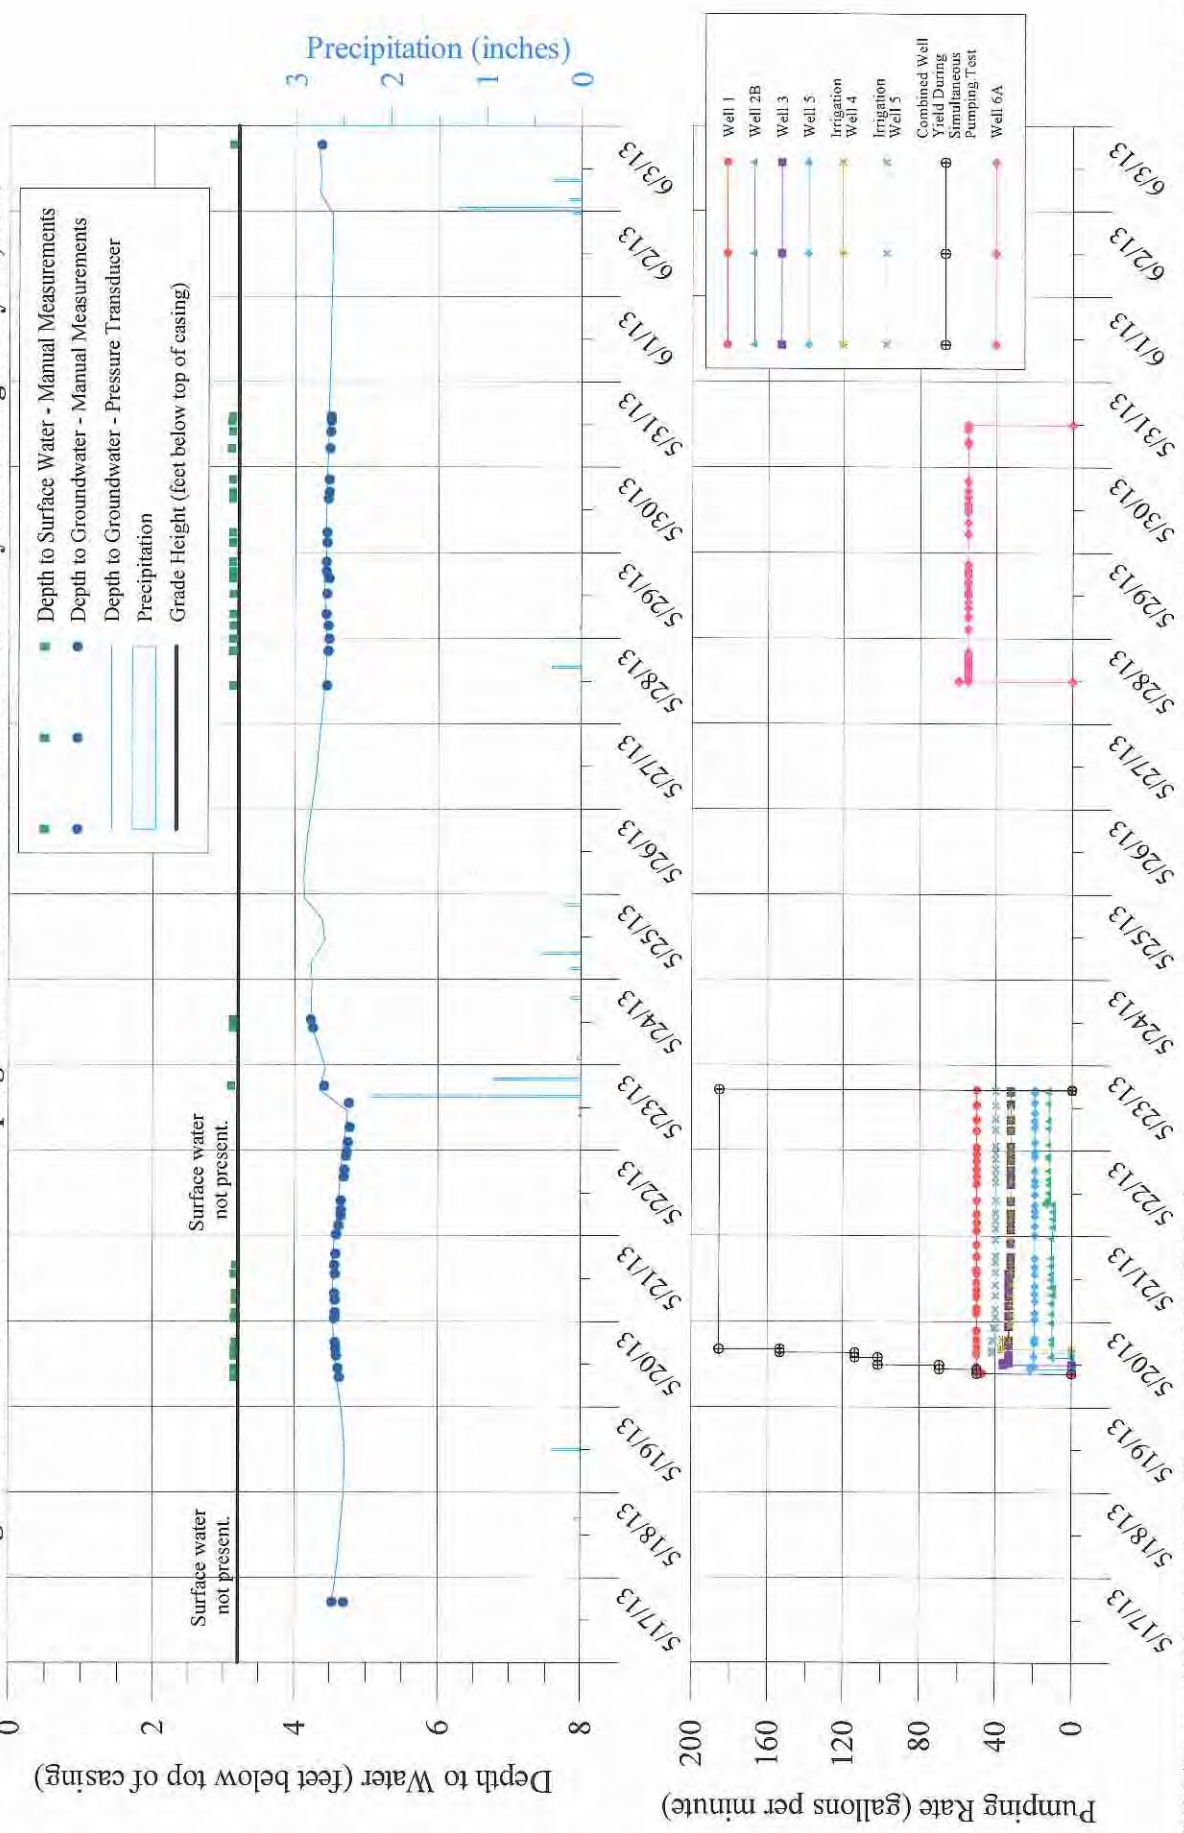
**Hydrograph of Water-Level Measurements Collected from Piezometer PZ-D During the Simultaneous Pumping Test Conducted on Proposed Wells 1, 2B, 3 and 5 and Existing Irrigation Wells 4 and 5 from May 20 Through May 23, 2013 and During the Individual 72-Hour Pumping Test Conducted on Well 6A from May 28 Through May 31, 2013**

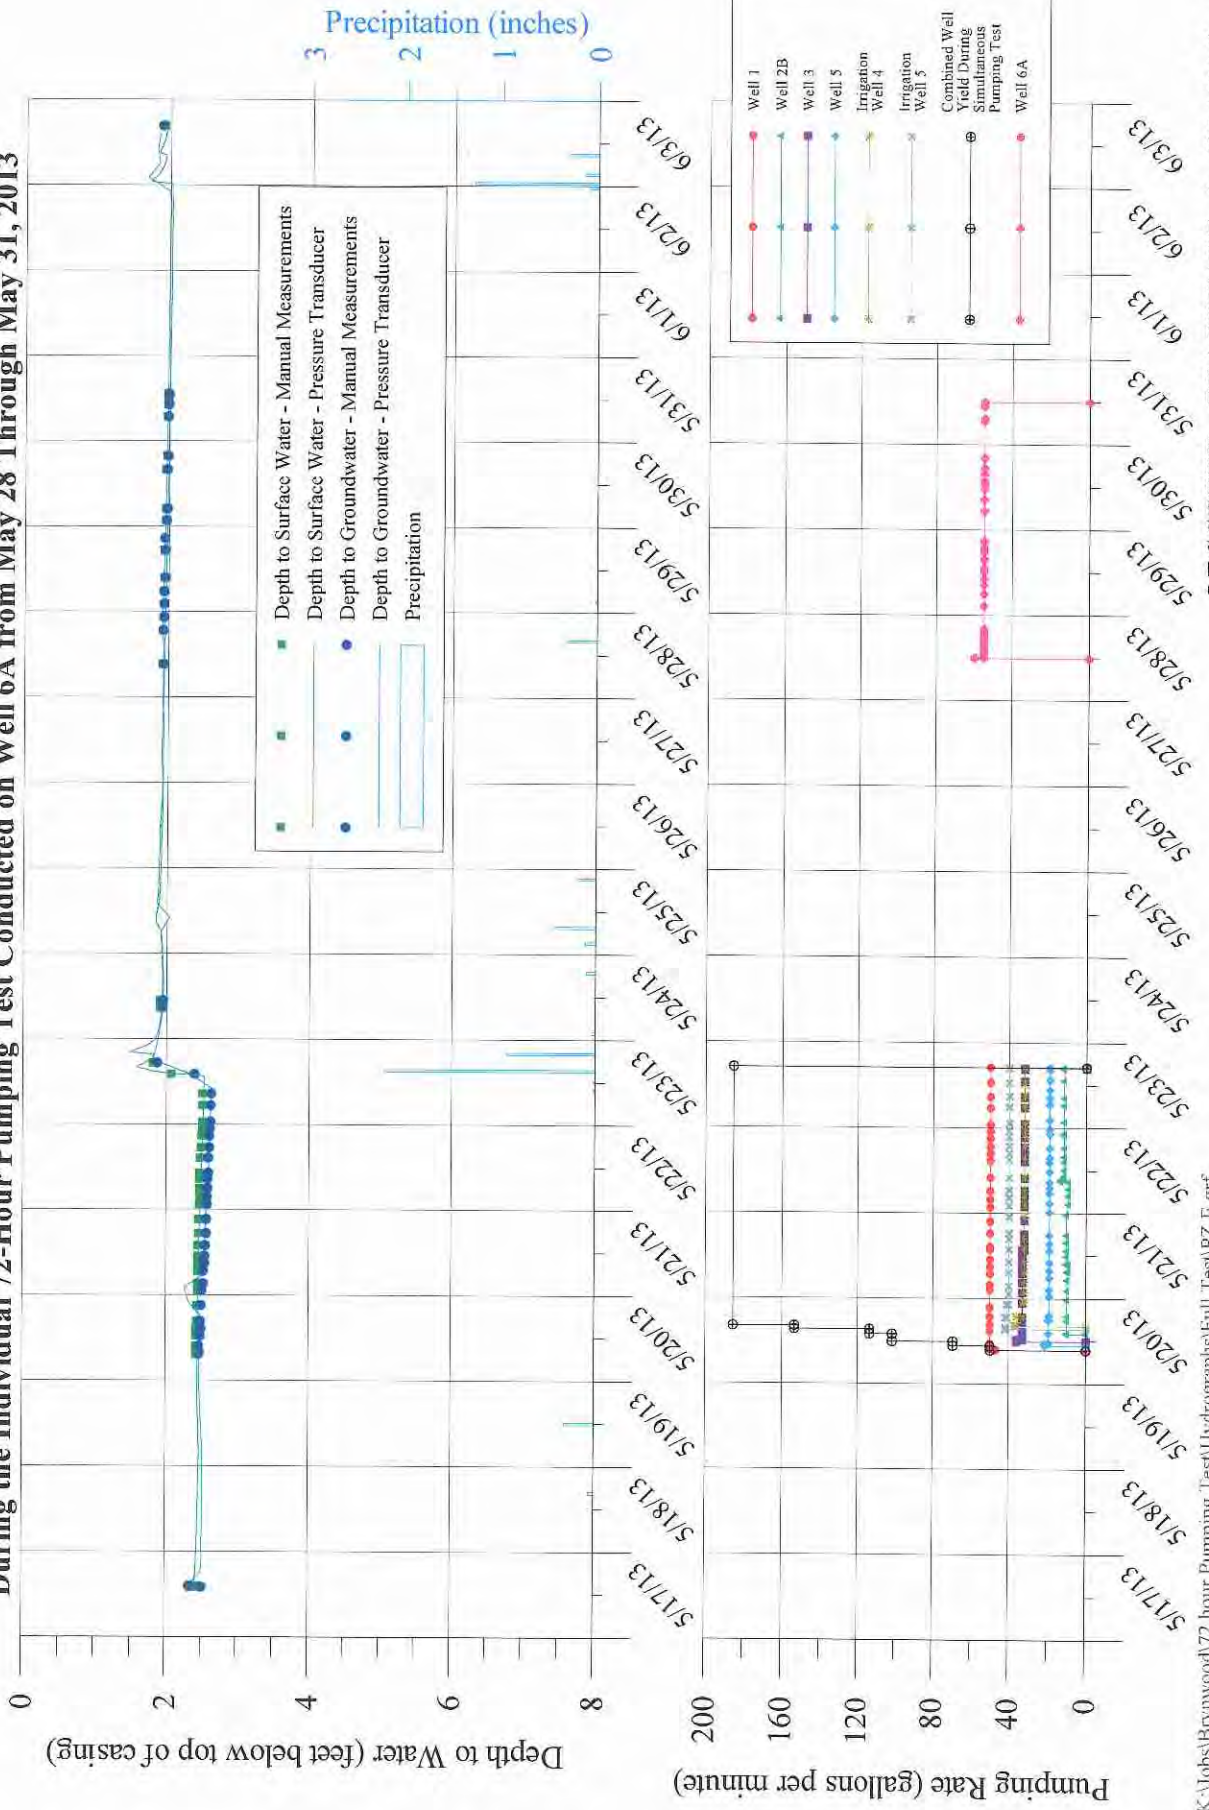
**Hydrograph of Water-Level Measurements Collected from Piezometer PZ-E During the Simultaneous Pumping Test Conducted on Proposed Wells 1, 2B, 3 and 5 and Existing Irrigation Wells 4 and 5 from May 20 Through May 23, 2013 and During the Individual 72-Hour Pumping Test Conducted on Well 6A from May 28 Through May 31, 2013**

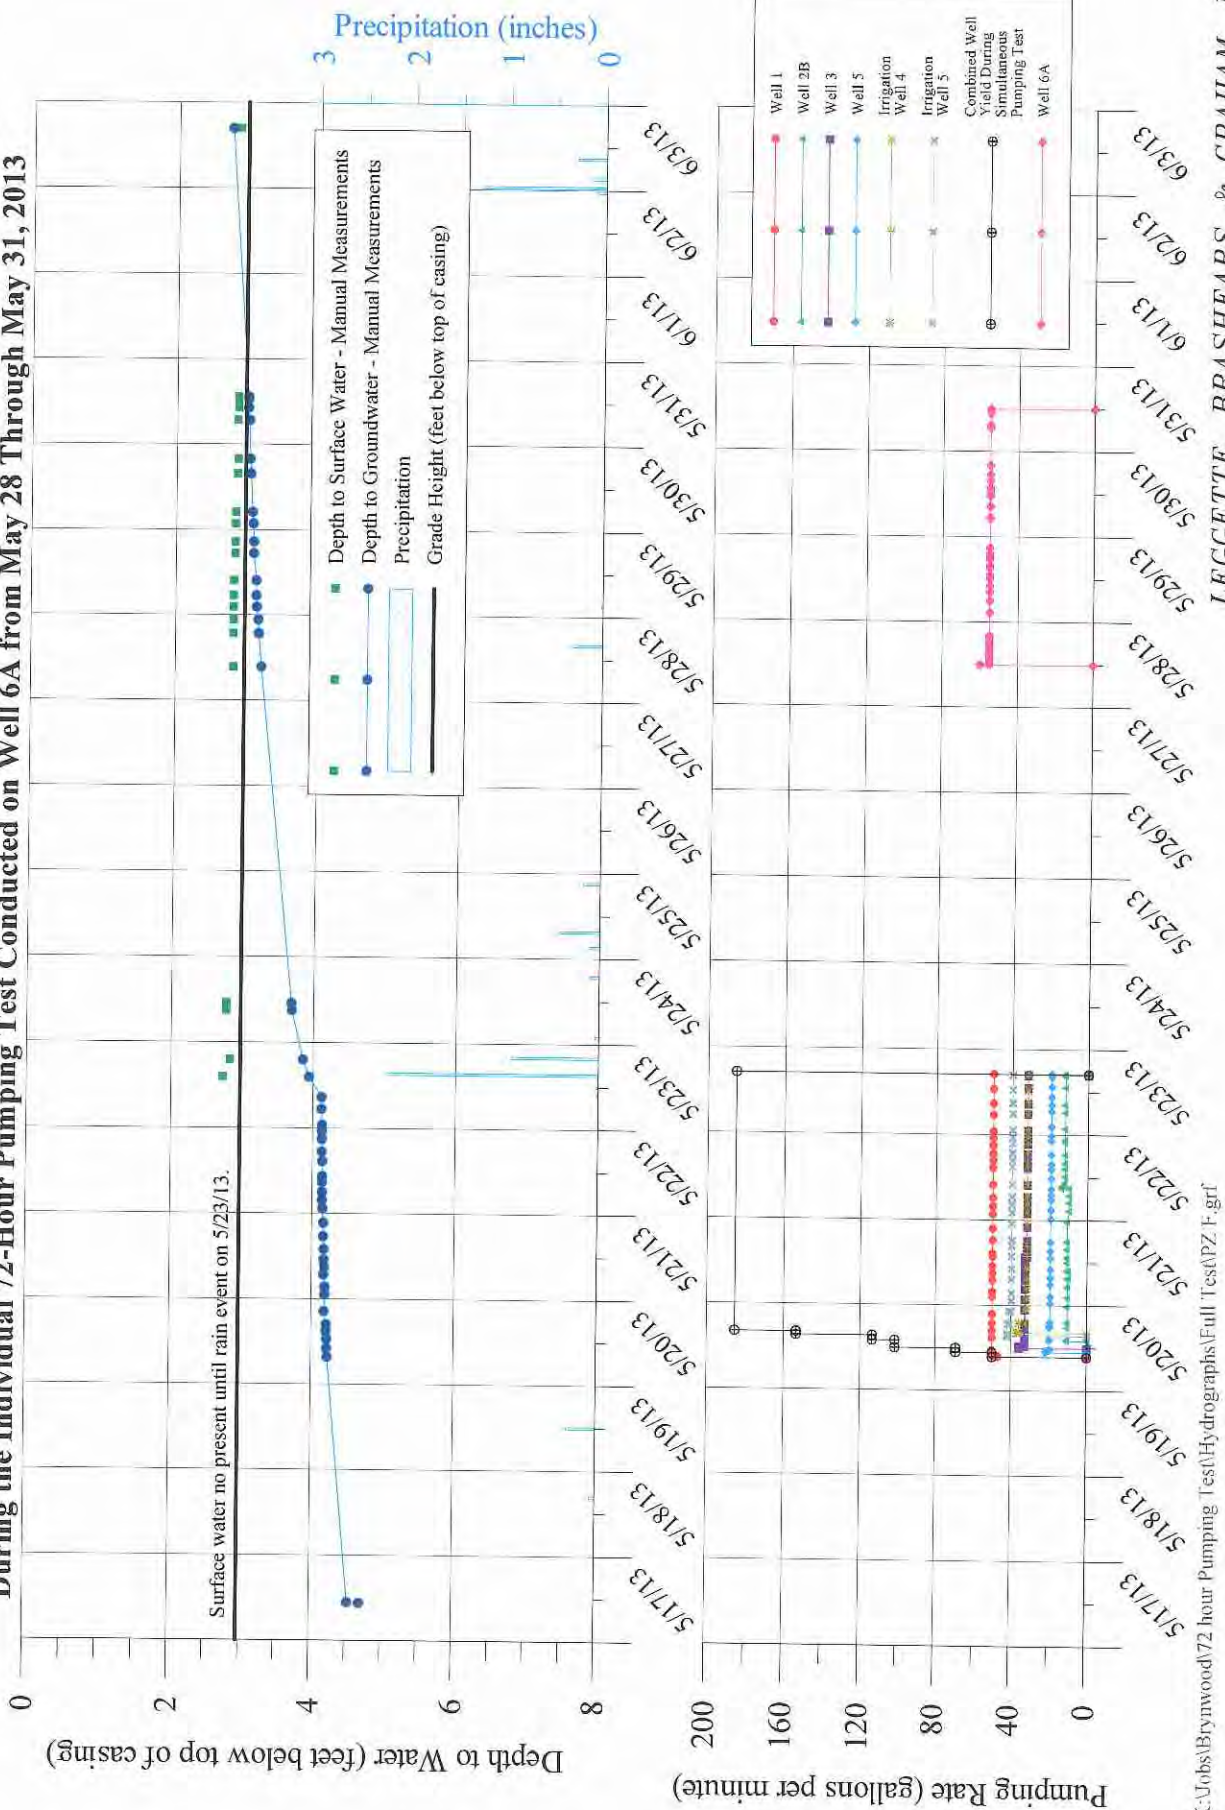
**Hydrograph of Water-Level Measurements Collected from Piezometer PZ-F During the Simultaneous Pumping Test Conducted on Proposed Wells 1, 2B, 3 and 5 and Existing Irrigation Wells 4 and 5 from May 20 Through May 23, 2013 and During the Individual 72-Hour Pumping Test Conducted on Well 6A from May 28 Through May 31, 2013**

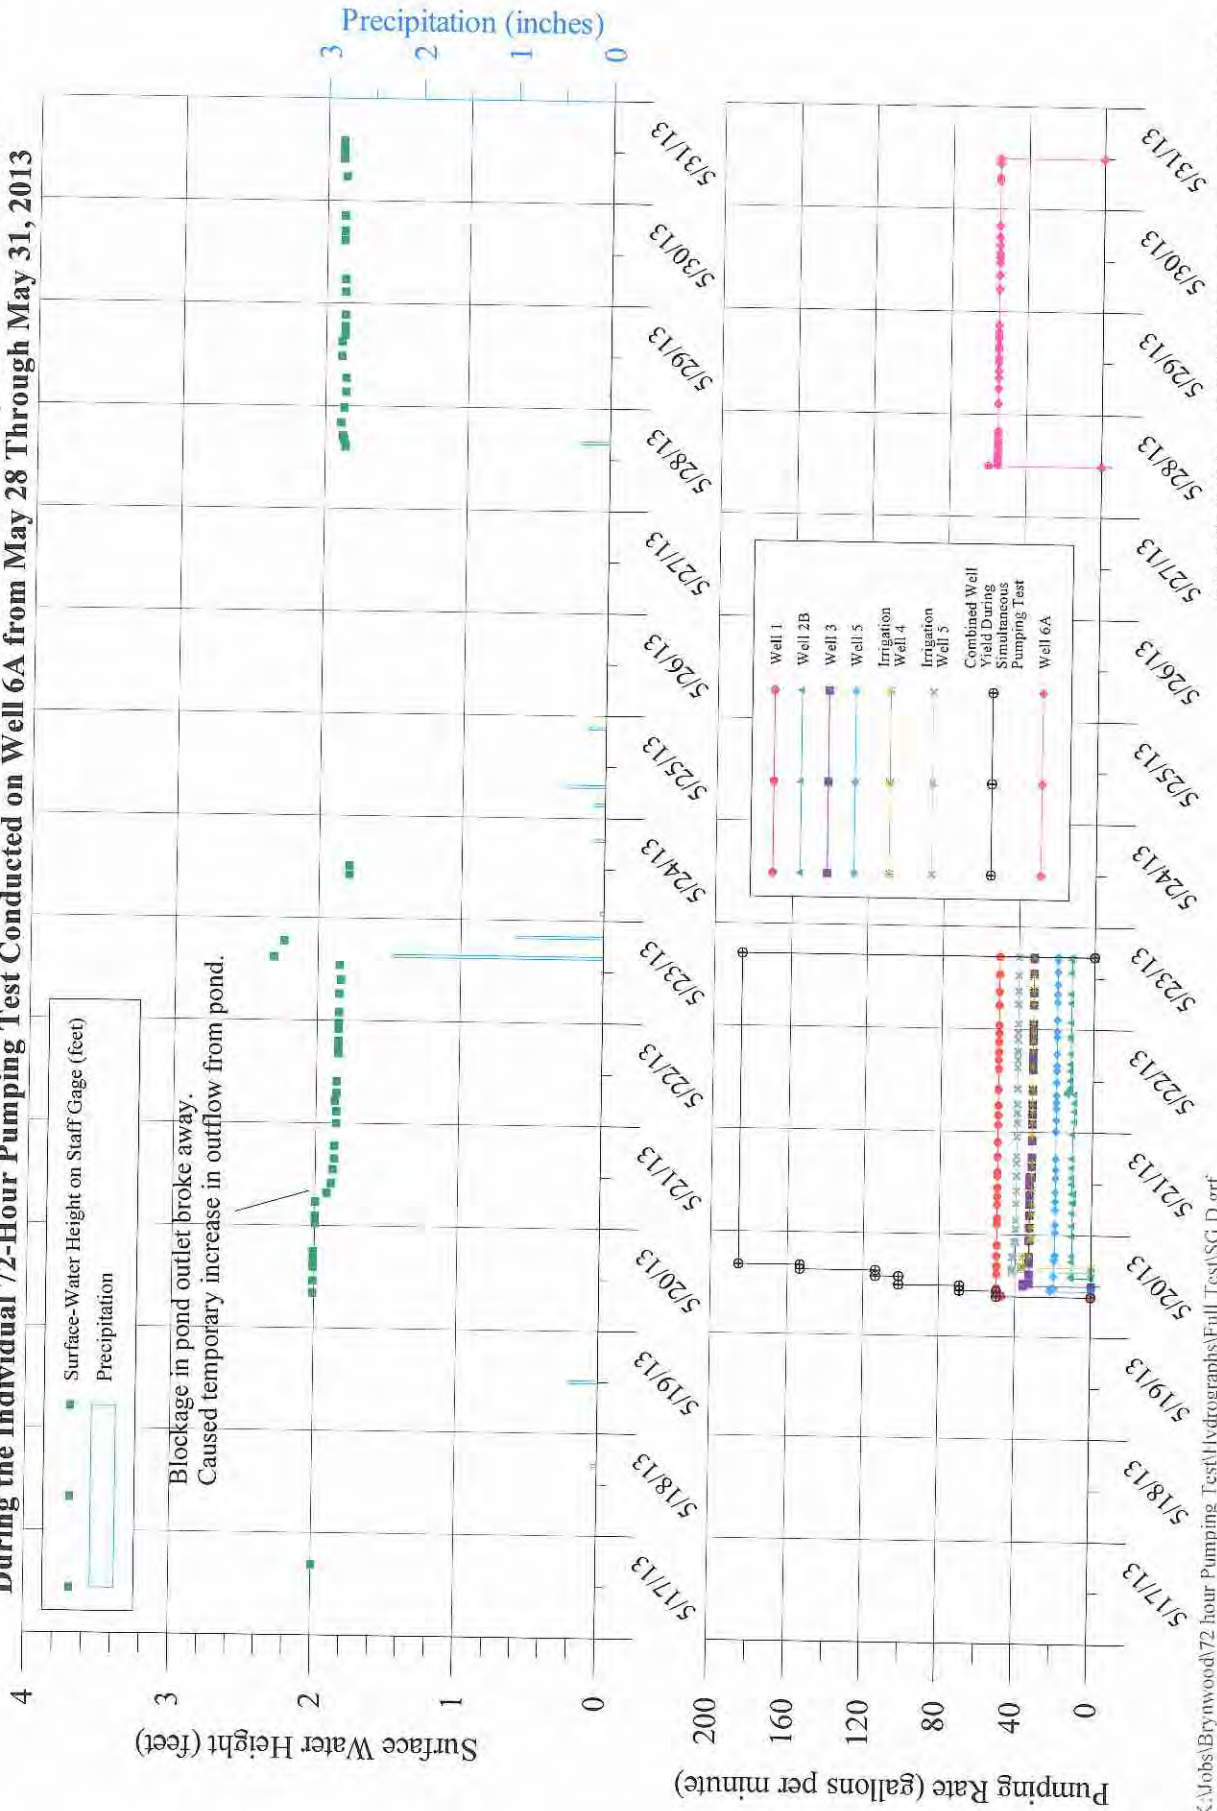
**Hydrograph of Water-Level Measurements Collected from Staff Gage SG-D During the Simultaneous Pumping Test Conducted on Proposed Wells 1, 2B, 3 and 5 and Existing Irrigation Wells 4 and 5 from May 20 Through May 23, 2013 and During the Individual 72-Hour Pumping Test Conducted on Well 6A from May 28 Through May 31, 2013**
