| PROJECT NAME: | WATER DISTRICT NO.2 WINDMILL #1 REHABILITATION |

TITLE SHEET

FLOOR PLANS

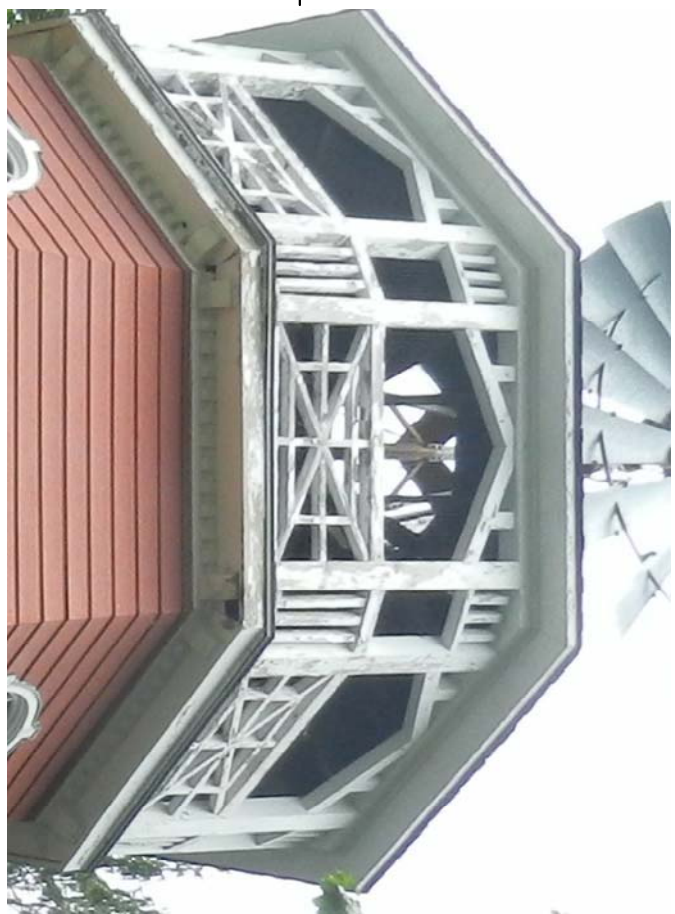
- 1 EXISTING WOOD TRIM / ORNAMENT / MOLDING DETAILS TO REMAIN. REMOVE LOOSE PAINT, SAND AND PAINT. OPTION: REMOVE AND REPLACE ROTTEN MATERIAL, AND REPLACE NIKIND WITH CLEAR CEDAR. TO MATCH EXISTING DIMENSIONS EXACTLY.
- 2 REPLACE ASPHALT ROOF SHINGLES TO MATCH EXISTING WHERE NECESSARY (WHERE SIGNS OF DETEIORATION OR ROT ARE PRESENT) PROVIDE ICE AND WATER SHIELD AND REPLACE SHEATHING WITH COR PL WOOD WHERE REQUIRED.
- NOTE: REPLACING NIKIND EXTENSIVELY DETERIORATED OR MISSING PARTS OF WOOD FEATURES WHEN THERE ARE SURVIVING PROTOTYPES SUCH AS BRACKETS, MOLDING, OR SECTIONS OF SIDING. NEW WORK SHOULD MATCH THE OLD IN DESIGN COLOR AND TEXTURE AND BE UNOBTUSIVELY DATED TO GUIDE FUTURE RESEARCH AND TREATMENT (TYPICAL).

- 2a EXISTING WINDMILL TO REMAIN (INVESTIGATE TO MAKE SURE STRUCTURALLY SOUND)

- AREA: MIDDLE (VENTING WINDOWS)
- 3 EXISTING WOOD TRIM / ORNAMENT DETAILS. SCRAP OFF LOOSE PAINT, SAND AND RE-PAINT. OPTION: REPLACE WITH NEW CLEAR MATERIAL WHERE NECESSARY TO MATCH EXISTING EXACT DIMENSIONS
- 4 REPLACE ANY CLAYBORND SIDING TO MATCH EXISTING WHERE DAMAGED, ROTTED, ETC.
- 5 REPAIR/NT CLAYBORND TO MATCH EXISTING WHERE ONLY VISUALLY DAMAGED (Removing damaged or deteriorated paint only to the red sand layer using the gentlest method possible prior to repainting. Apply compatible paint coating systems following proper surface preparation. (typical))

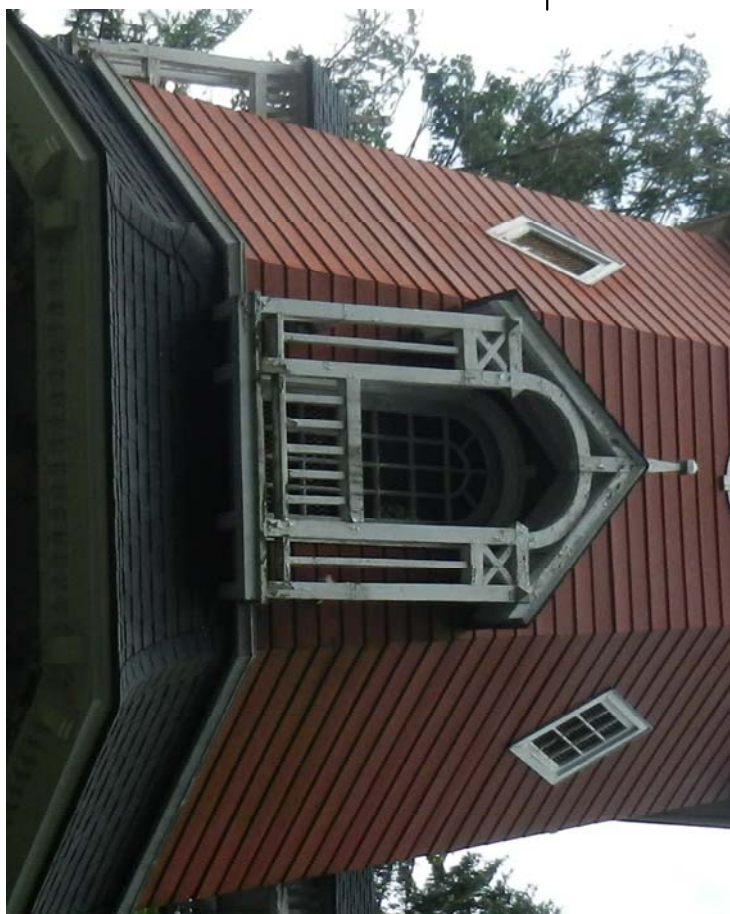
- AREA: FIRST FLOOR ROOF / PORTICO
- 8 EXISTING WOOD DECORING AND RAILINGS TO BE SAVED AND PAINTED. REPLACE ROTTED DECORING AND RAILING SYSTEM WITH WOOD. TO MATCH EXACT EXISTING DIMENSIONS / STYLE - REPLACE ROTTED TRIM WITH WOOD (PIC TRIM PRICE OPTION)
- 9 REPLACE ASPHALT SHINGLES TO MATCH EXISTING WHERE NECESSARY, PROVIDE ICE AND WATER SHIELD AND REPLACE SHEATHING WITH COR PL WOOD WHERE REQUIRED.
- 10 REPAIR ANY TRIM MOLDING WHEN NOT BEING REPLACED IF NEEDED
- 11 PROVIDE ADDITIONAL ANCHORS AND TIES TO REINFORCE LIFT AT CONNECTIONS OF RAILERS TO BEAMS AND BRANIS TO COLUMNS, ETC. (TYPICAL)

AREA: STONE BASE

- 12 REPLACE ROTTED TRIM WITH WOOD MATERIAL (NEW TO MATCH EXISTING DIMENSIONS)
- 13 SAND, TREAT, PRIME AND RE-PAINT WHERE NECESSARY (TYPICAL)
- 14 REPLACE ROTTED DOWNERS WHERE NECESSARY WITH WOOD MATERIAL
- 15 REPLACE ANY OPENINGS TO HAVE HARDWARE CLOTH-GALVANIZED WIRE MESH 1/2" BY 1/2" SQUARE OPENINGS, WHERE NECESSARY (TYPICAL)
- 16 POWER WASH STONE WHERE NEEDED
- 17 REPAIR MASONRY WALLS AND OTHER MASONRY FEATURES BY REPOINTING THE MORTAR JOINTS WHERE THERE IS EVIDENCE OF DETEIORATION SUCH AS DISINTEGRATING MORTAR, CRACK IN MORTAR JOINTS, ETC. (TYPICAL)
- 18 -APPLY WATER REPELLENT COATING TO MASONRY ONLY AFTER REPOINTING AND ONLY IF MASONRY REPAIRS HAVE FAILED TO RESIST WATER PENETRATION PROBLEMS (TYPICAL)
- 19 REPAIR EXISTING WOOD SOFFITS WHERE NEEDED
